# Building Assessment Report

Inspection Address: 617 Texas St.  
Redlands, CA 92374

Prepared For: City of Redlands

Report Number: BARIECR9

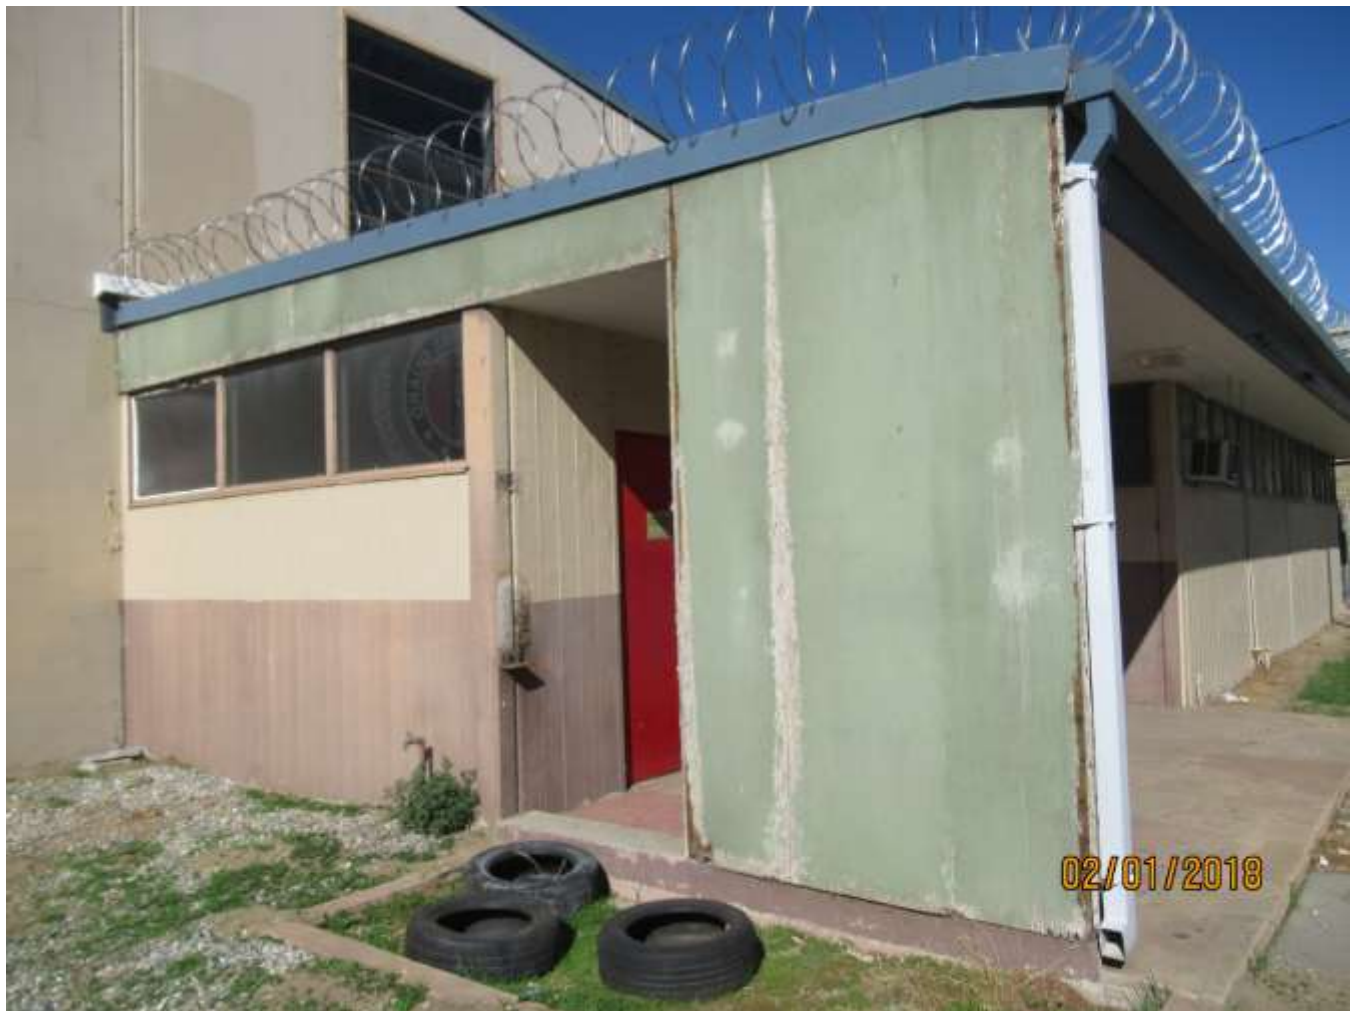
PHOTO 1

3.2.4 Signs of potential termite damage were noted in the visible wood work at the exterior front entry and the roof 2 x 12 roof fascia. Dryrot was also noted in these same areas of wood work that may have been initiated from the termite activity and from deferred maintenance of the wood materials of the building. It is recommended having a licensed termite contractor further evaluate the building, repair/replace all wood that has termite damage and chemically treat the building as needed.

Example of deteriorated sections of woodwork at the front exterior of the building

1. Have a licensed termite contractor further evaluate the building and repair all effected wood work

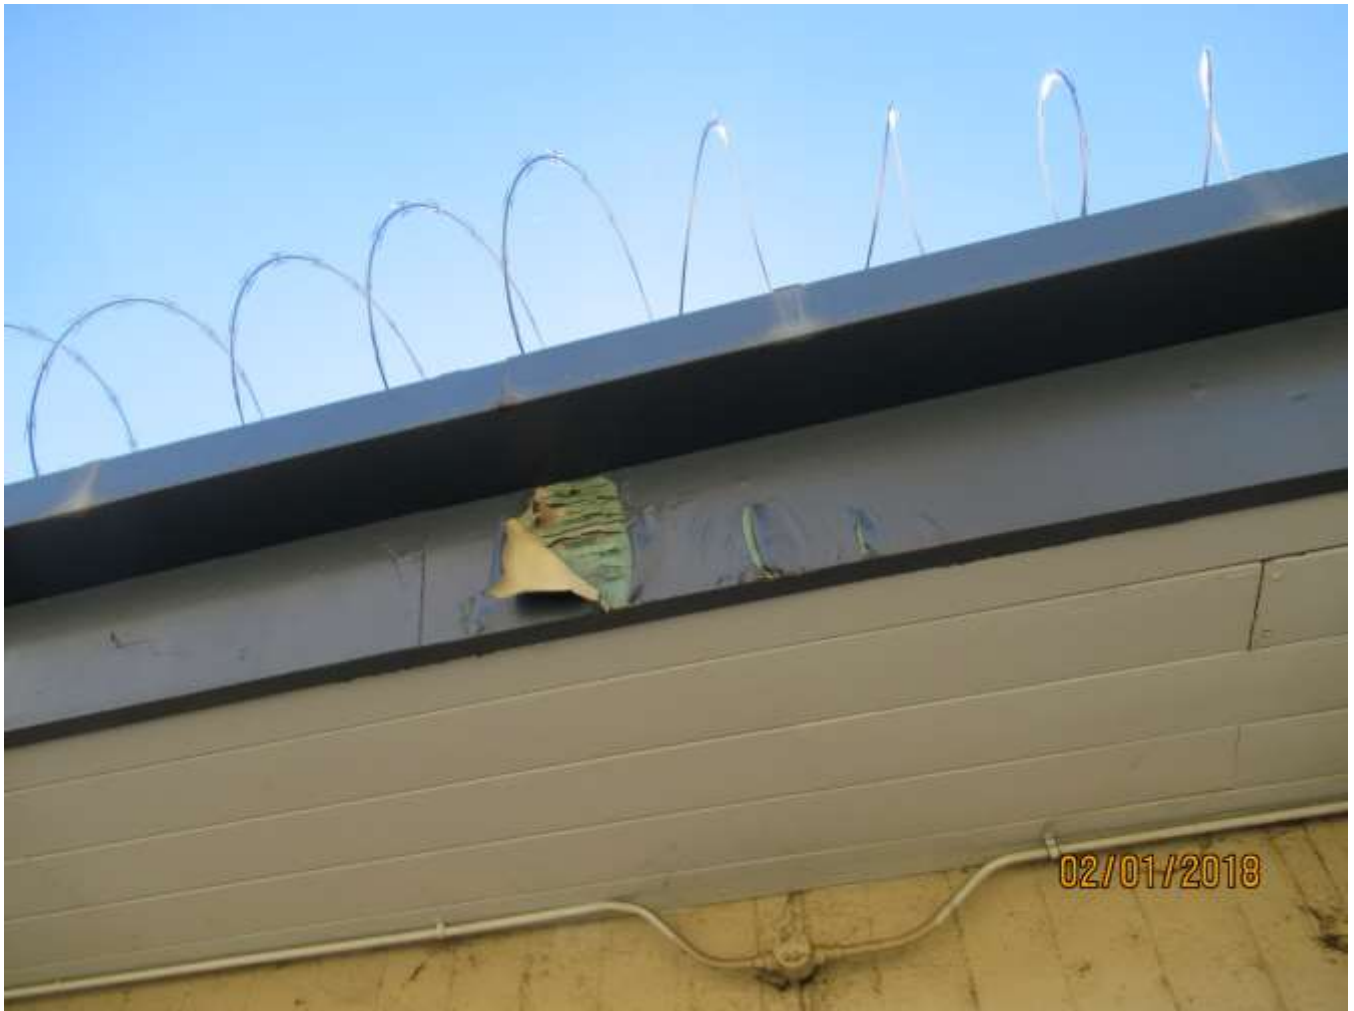
**PHOTO 2**

Example typical peeling paint and deteriorate sections of 2 x 12 wood roof fascia at the north side of the building

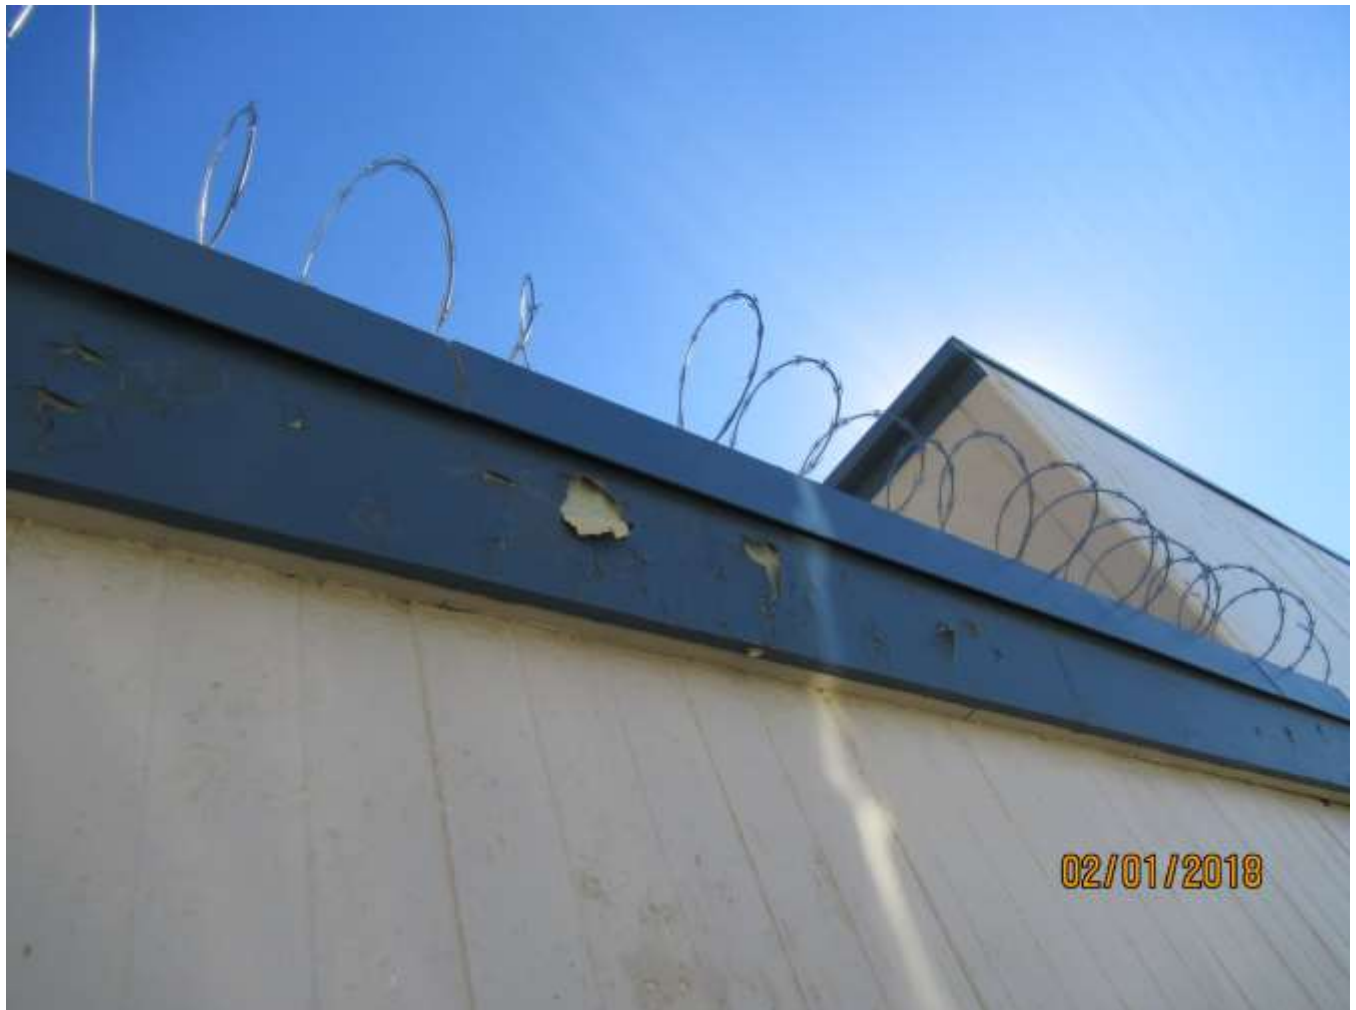
**PHOTO 3**

Example of typical peeling paint and deteriorated wood 2 x 12 roof fascia at the west side of the building

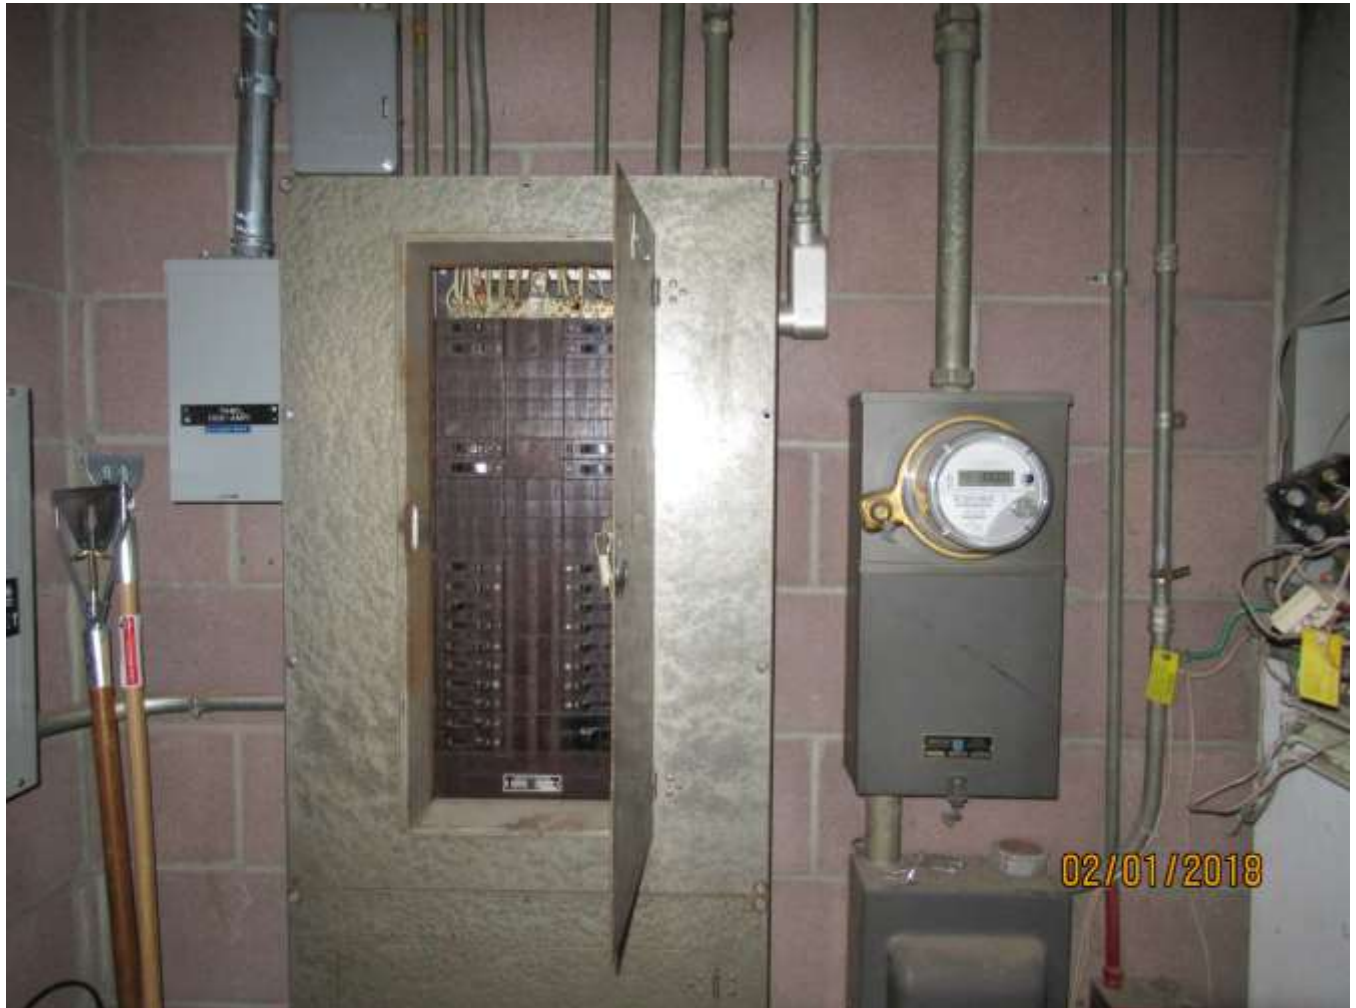
PHOTO 1

4.2.2 Electrical main panels and switchgear have an estimated useful life of approximately 50 years. The main panel appears to be past it's effective useful life. Is recommended having a license electrical contractor upgrade the main panel with a 400 amp 120/208 main switchgear.

Example of typical older main electrical panel and main panel and meter

1. Have a license electrical contractor upgrade the main electrical panel with a 400 AMP 120/208 main switchgear
2. Have a license electrical contractor further evaluate the building and perform a general audit, make all necessary repairs and upgrade all branch wiring as needed

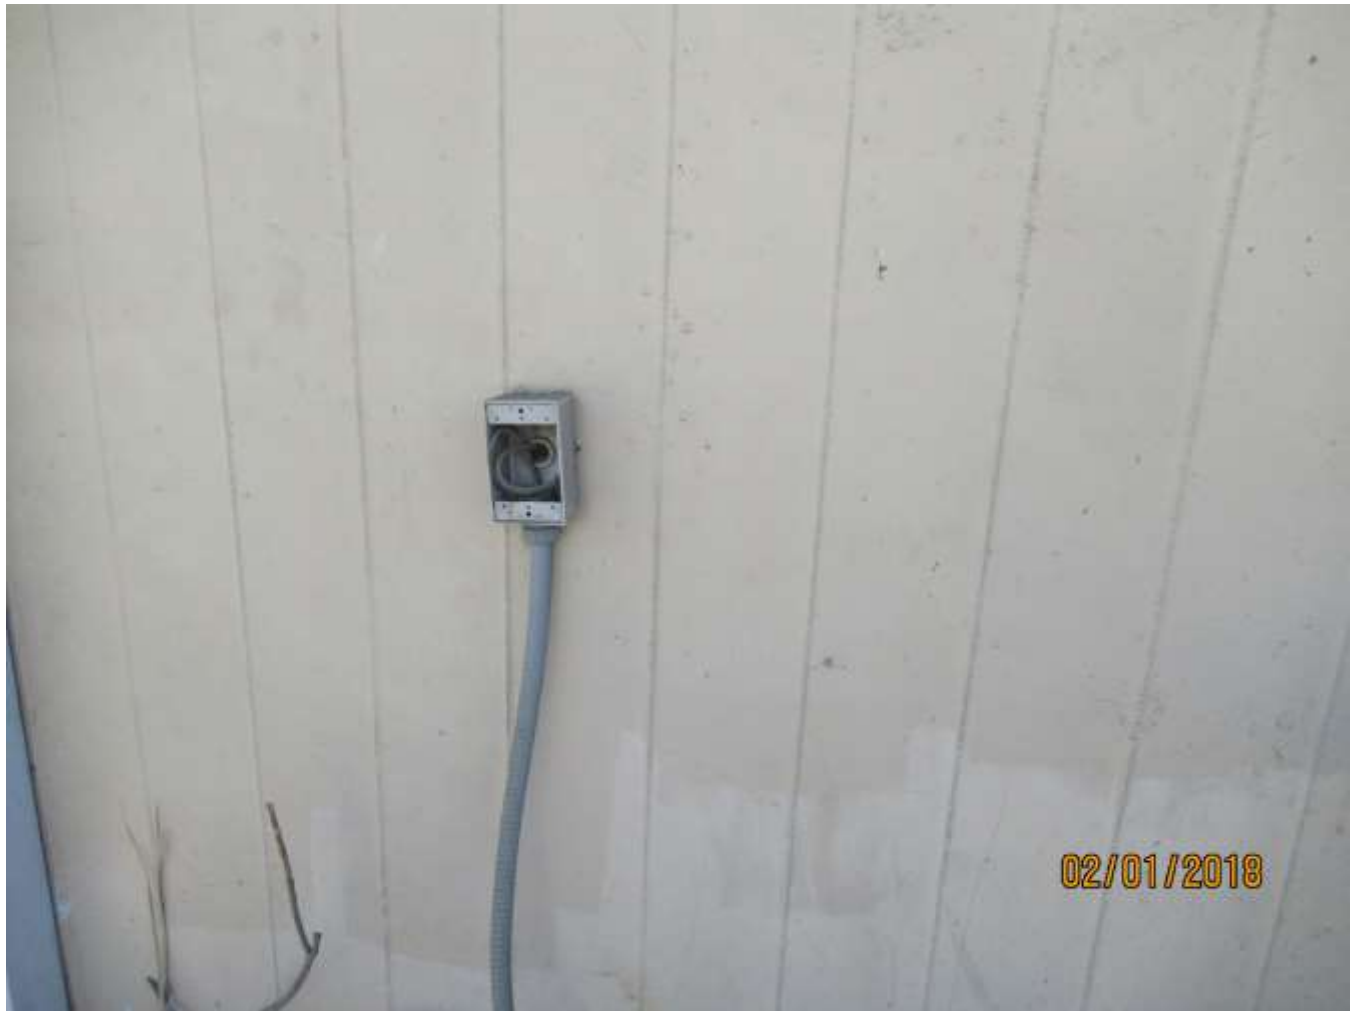
**PHOTO 2**

4.2.3 Abandoned conduit with exposed wiring were noted at the interior and exterior of the building. Missing junction box covers were also noted that the interior of the building. Some wiring and conduit have been upgraded however there is still about 50% of the branch wiring that is older and has required to be upgraded. It is recommended having a license local contractor perform a general audit of the building, make any necessary upgrades and repairs as needed.

Example of typical abandoned conduit and electrical J box at the exterior of the building

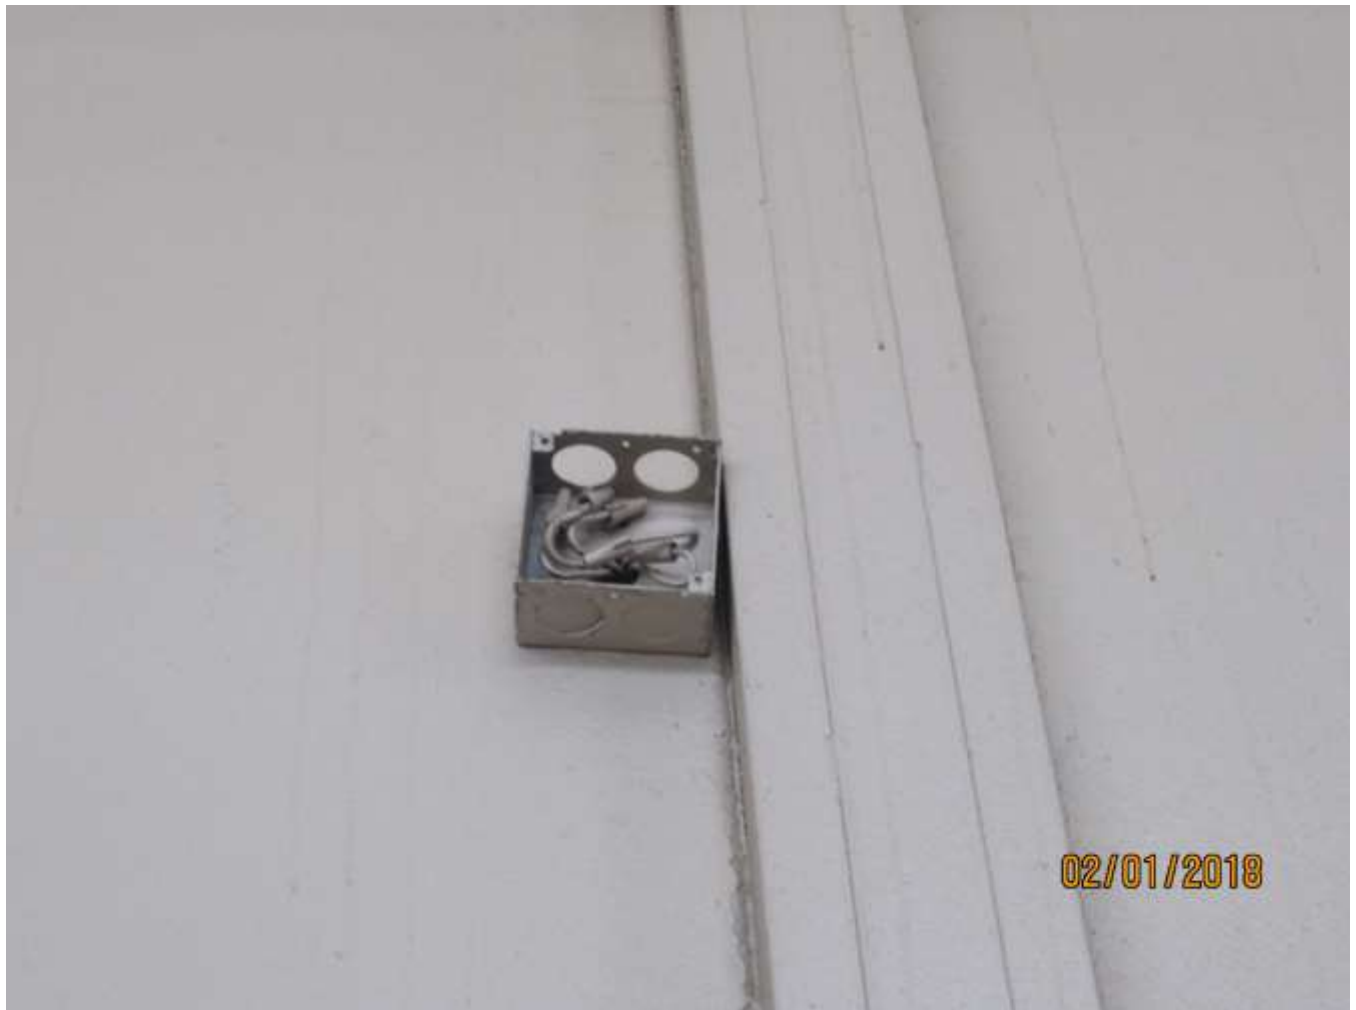
**PHOTO 3**

Example of typical missing J box cover plate

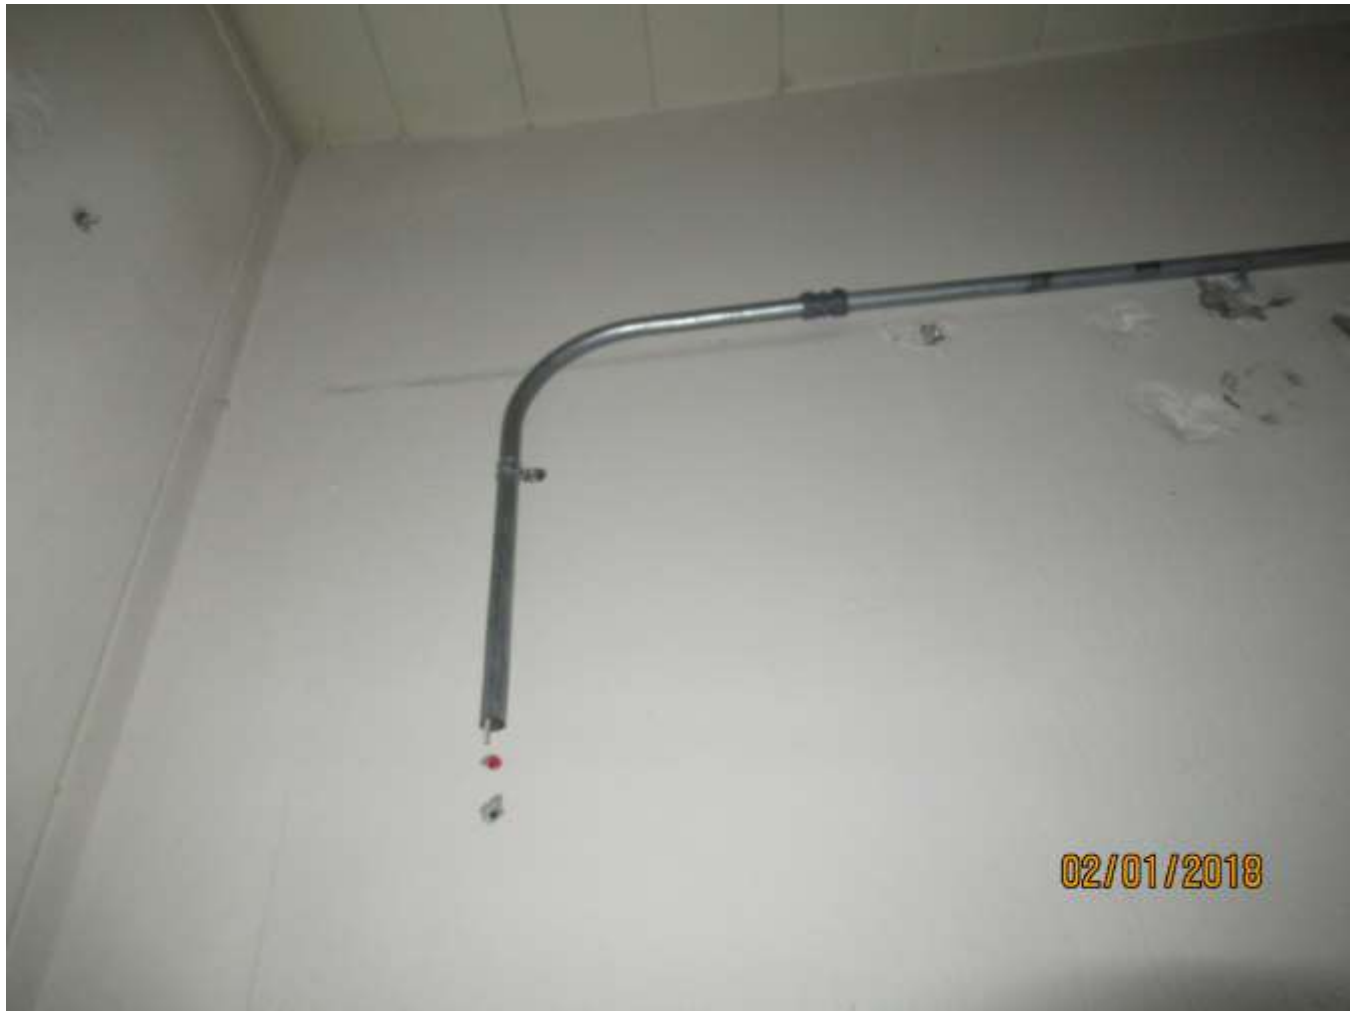
**PHOTO 4**

Example of typical abandoned conduit and expose wiring

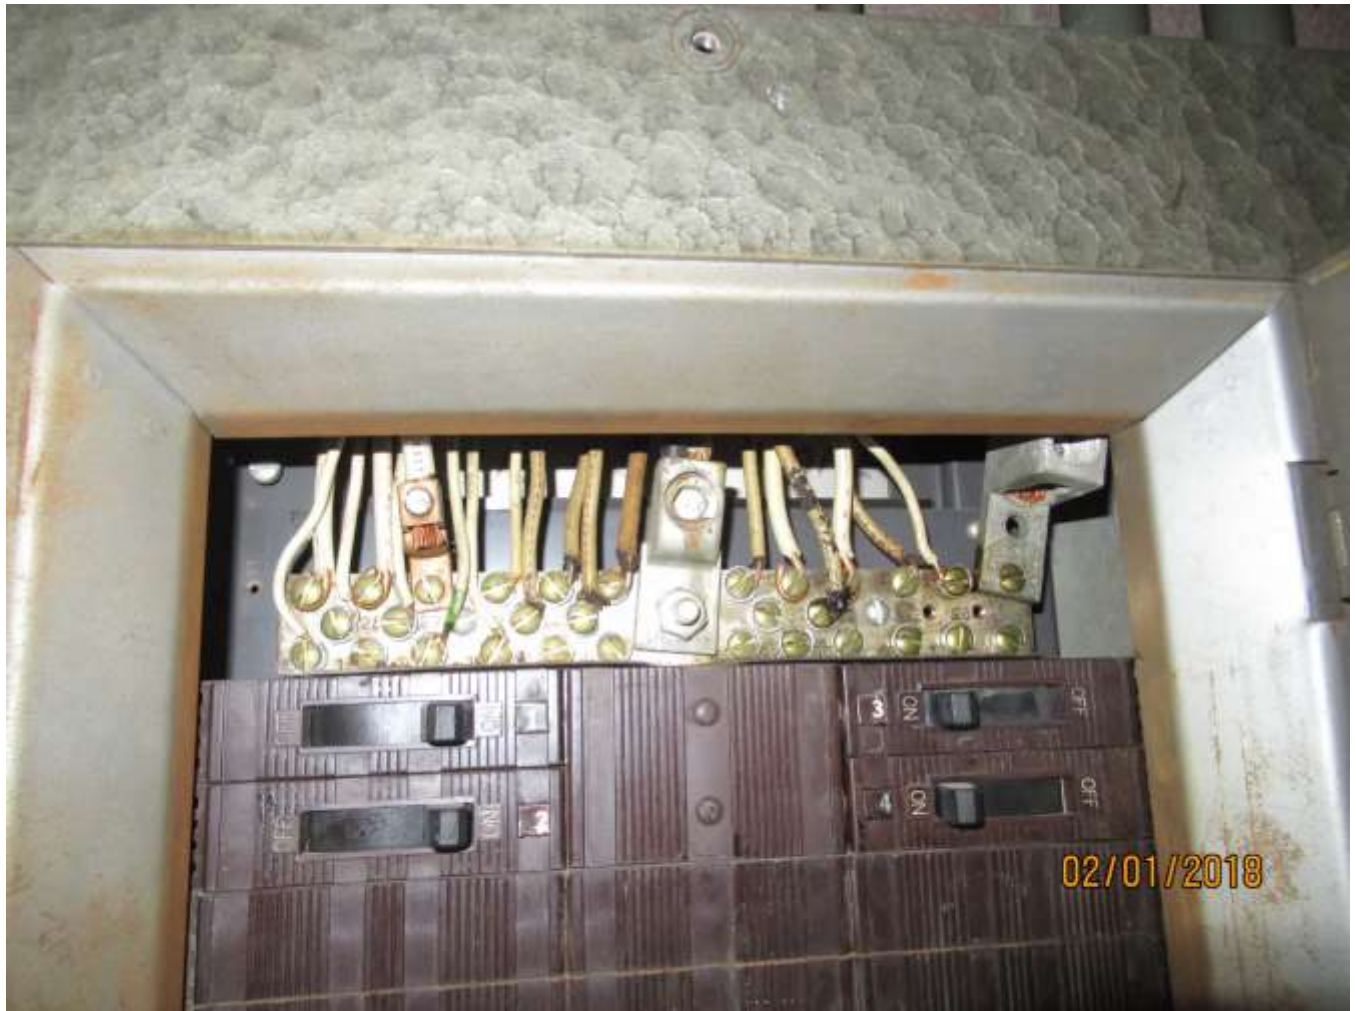
PHOTO 5

Example of typical older wiring

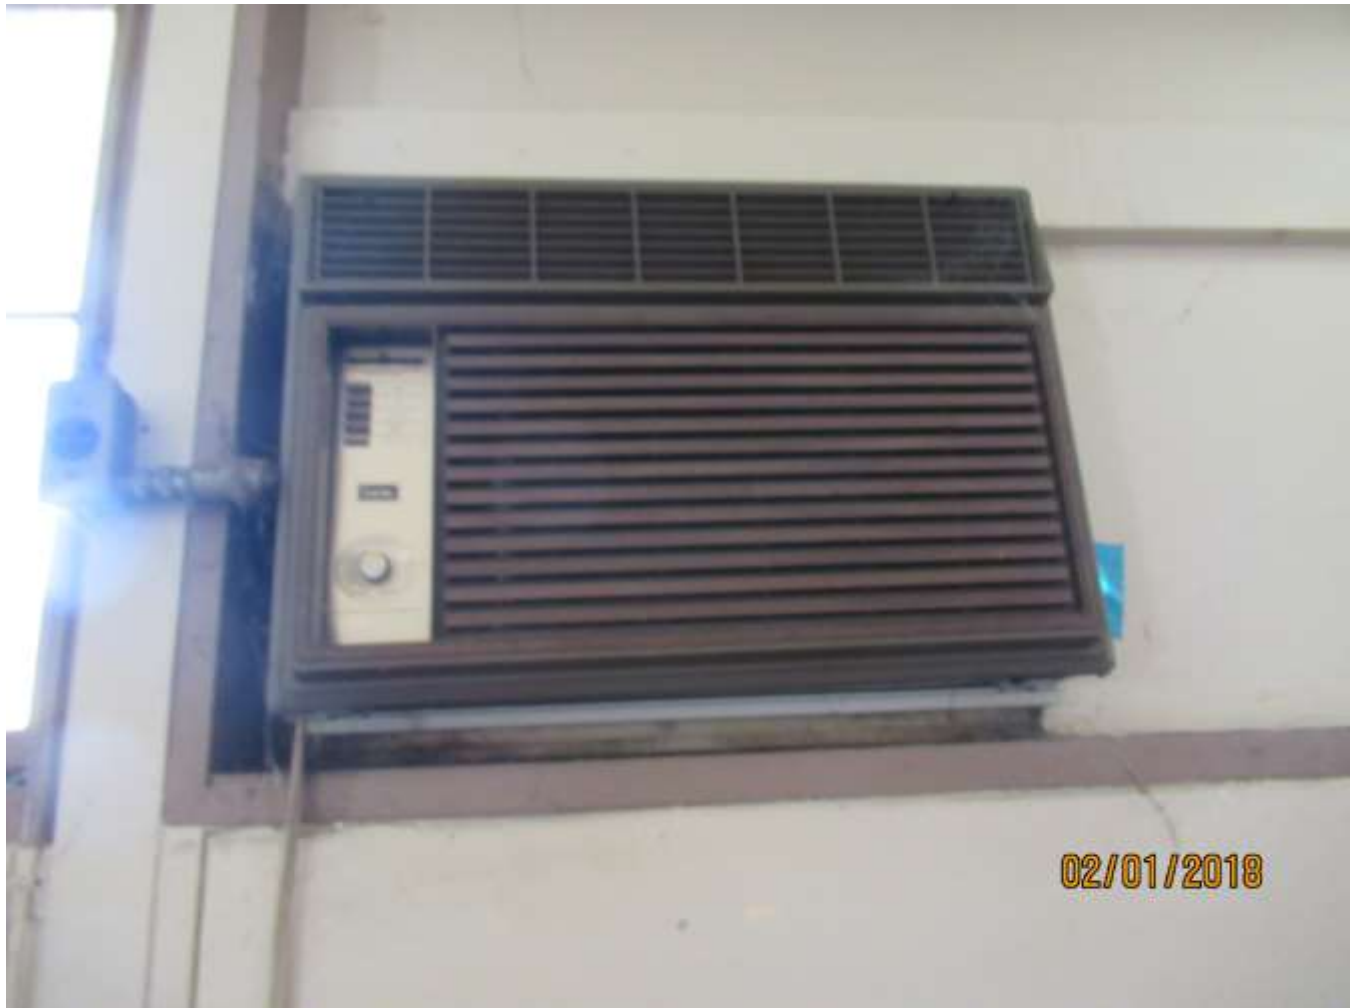
Example of typical wall mounted AC unit

5.2.4 The wall mounted A/C units are insufficient to properly air condition the office space. It is recommended having a license HVAC contractor install roof mounted A/C units for all of the office space.

1. Have a licensed HVAC contractor install roof mounted A/C units for the office section of the building.
2. Have a licensed HVAC contractor replace all of the ceiling mounted furnaces in the warehouse that are past their affected useful life

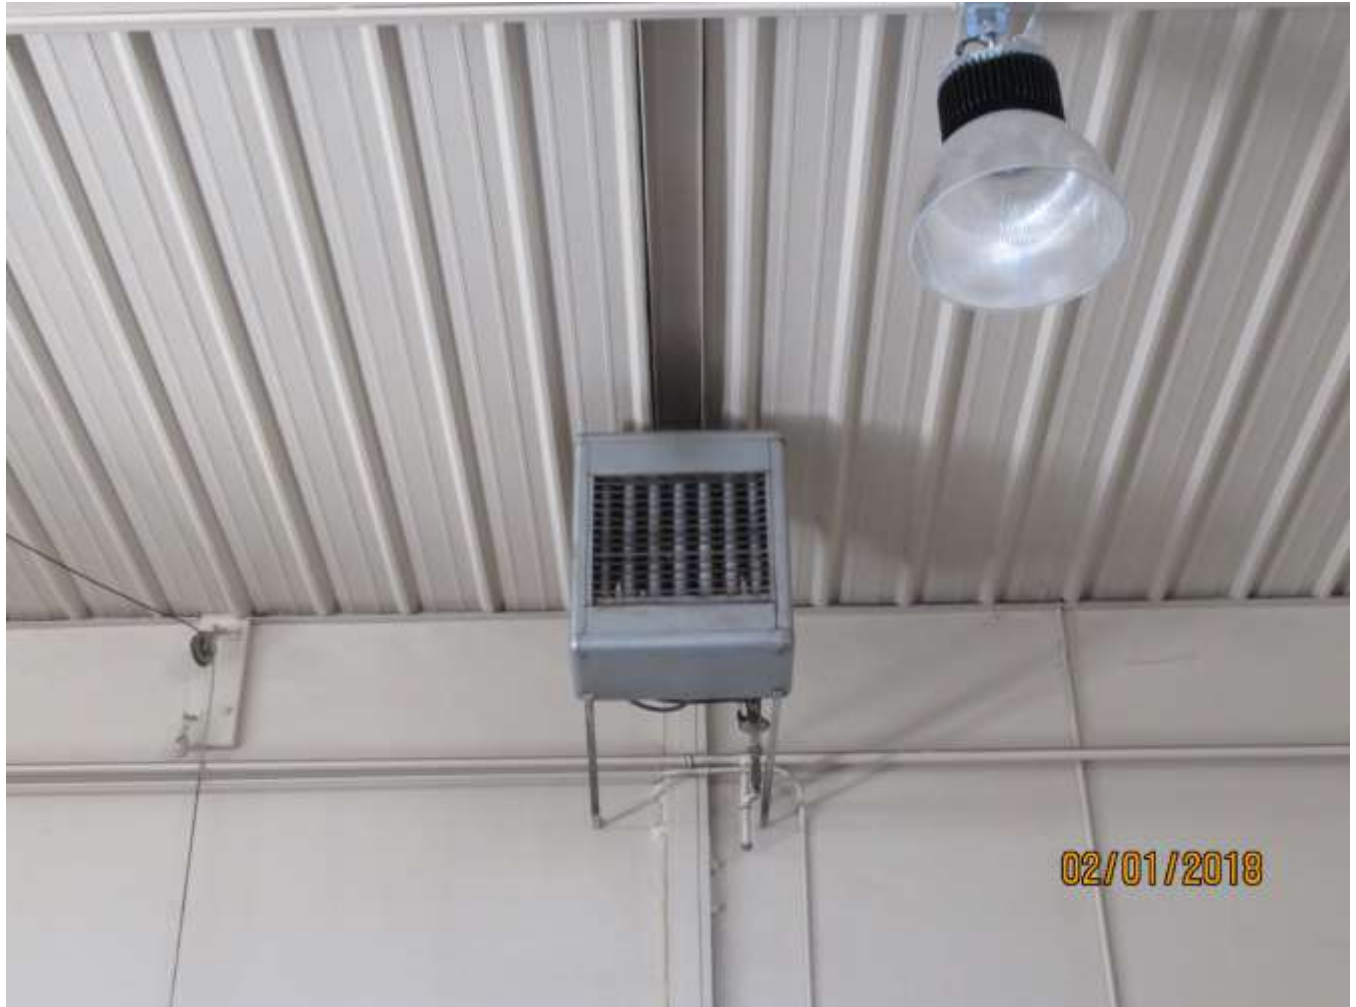
Example of typical ceiling mounted furnace in the warehouse

5.2.5 The ceiling mounted furnaces for the warehouse are all past their effective useful life. It is recommended having a licensed HVAC contractor replace all of the ceiling mounted furnaces in the warehouse.

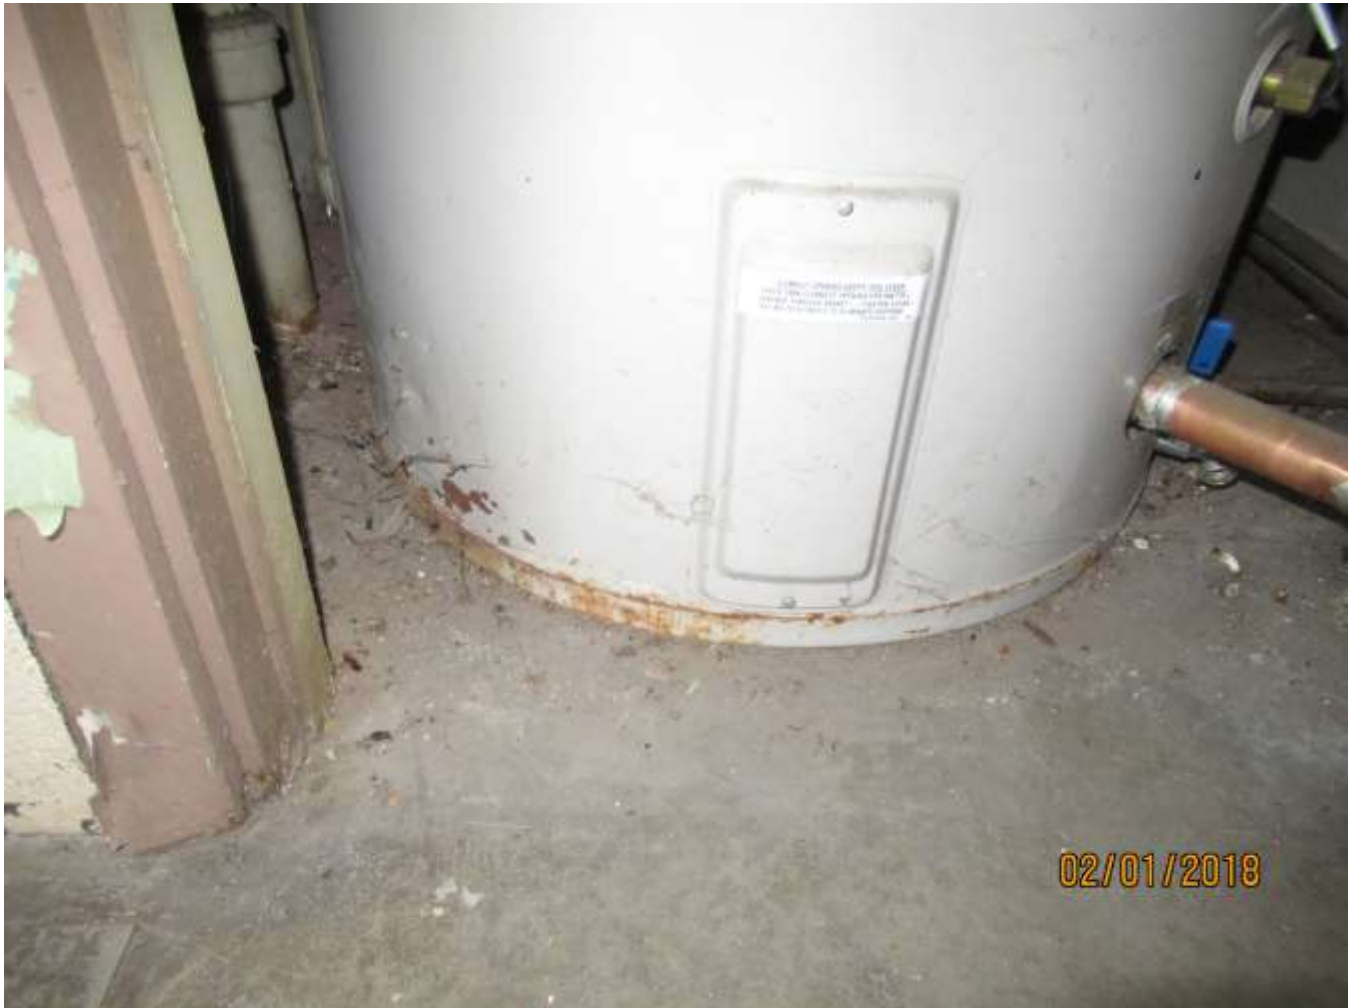
PHOTO 1

7.2.3 The water heater was noted as having oxidation at the base of that unit and is past its effective useful life. It is recommended having a licensed plumbing contractor replace the water heater.

Example of oxidized section of water heater at the base of the unit

1. Have a licensed plumbing contractor replace the water heater

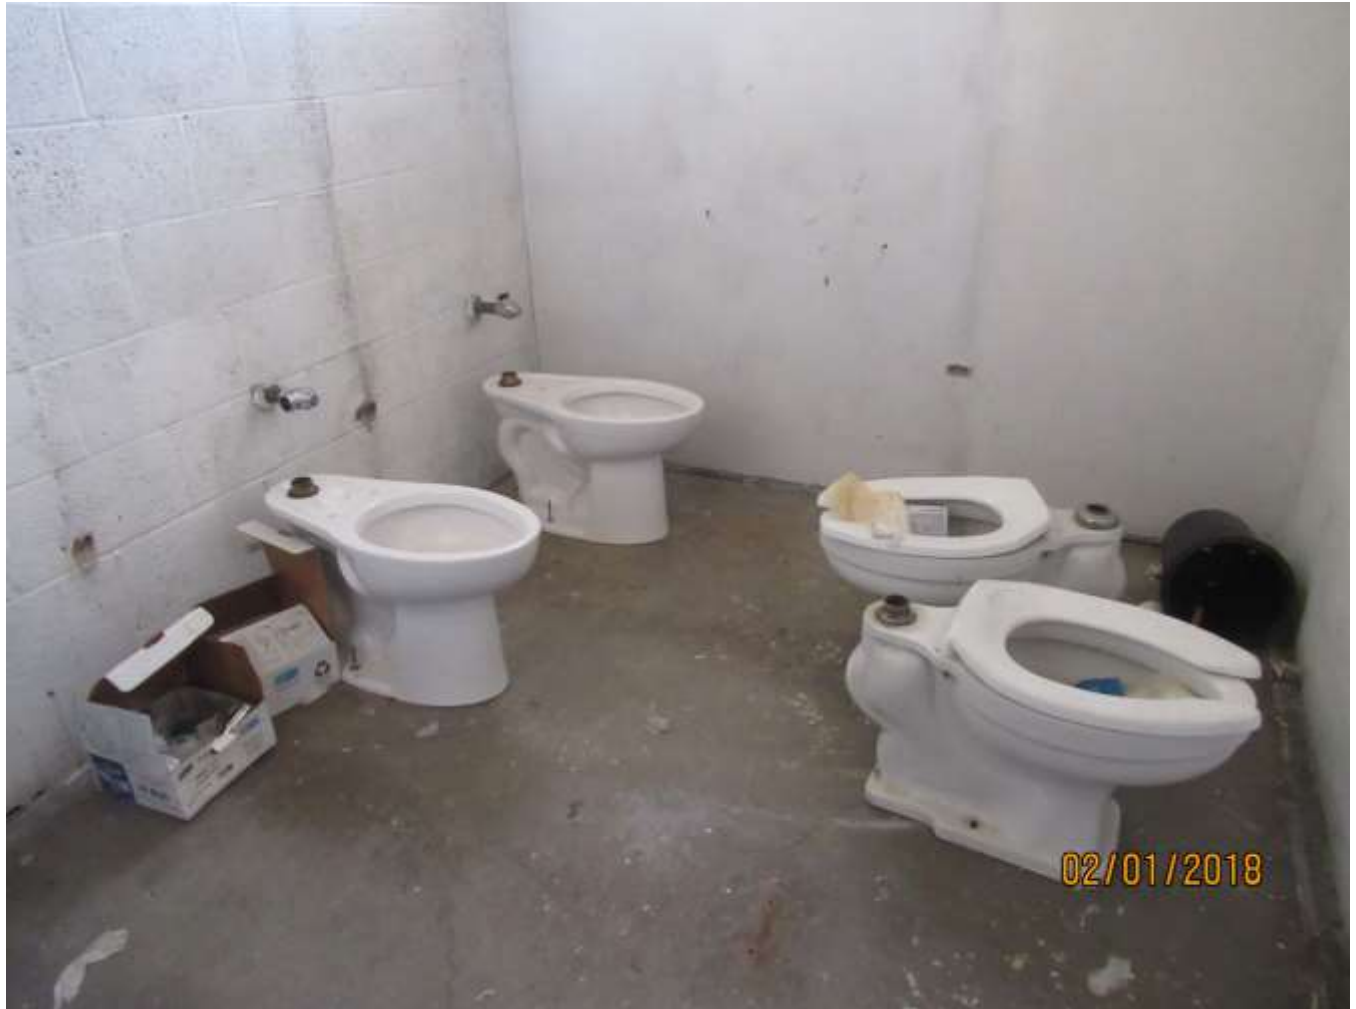
**PHOTO 2**

7.2.4 Many of the restroom plumbing fixtures have been disconnected and are all in overall poor condition. It is recommended having a licensed plumbing contractor replace all of the restroom and kitchenette plumbing fixtures. These cost will be covered in section 9.0.

Example of typical restroom plumbing fixtures that have been disconnected and are in overall poor condition

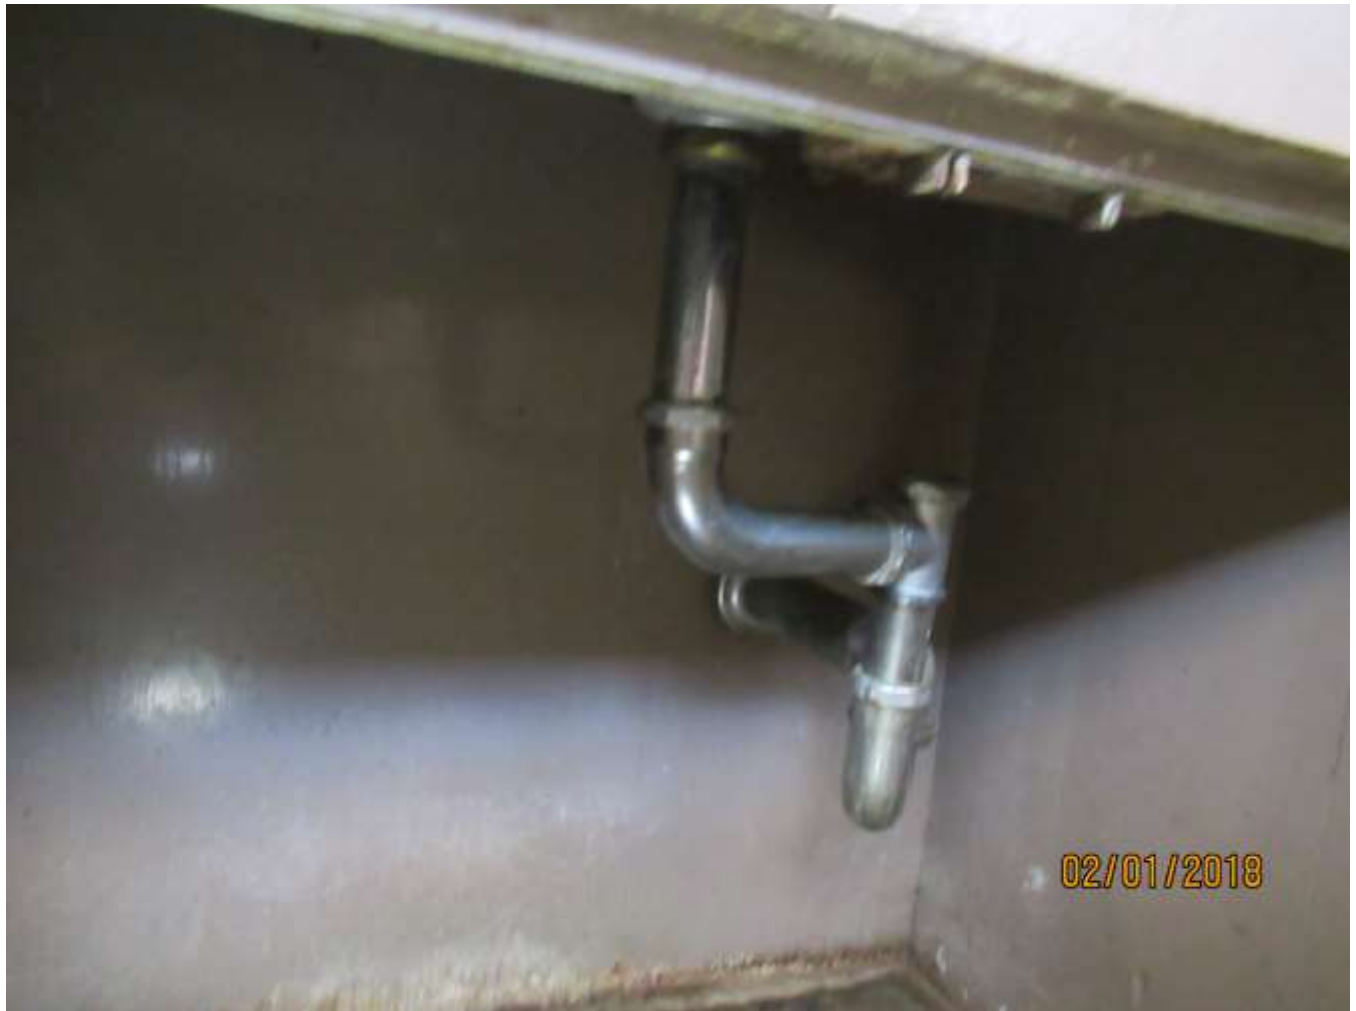
**PHOTO 3**

7.2.2 Missing sections of the visible plumbing waste lines were noted in the break room and in the restrooms that are required to be replaced. These costs will be covered in the office and restroom remodel in section 9.0.

Example of typical missing plumbing waste and supply lines

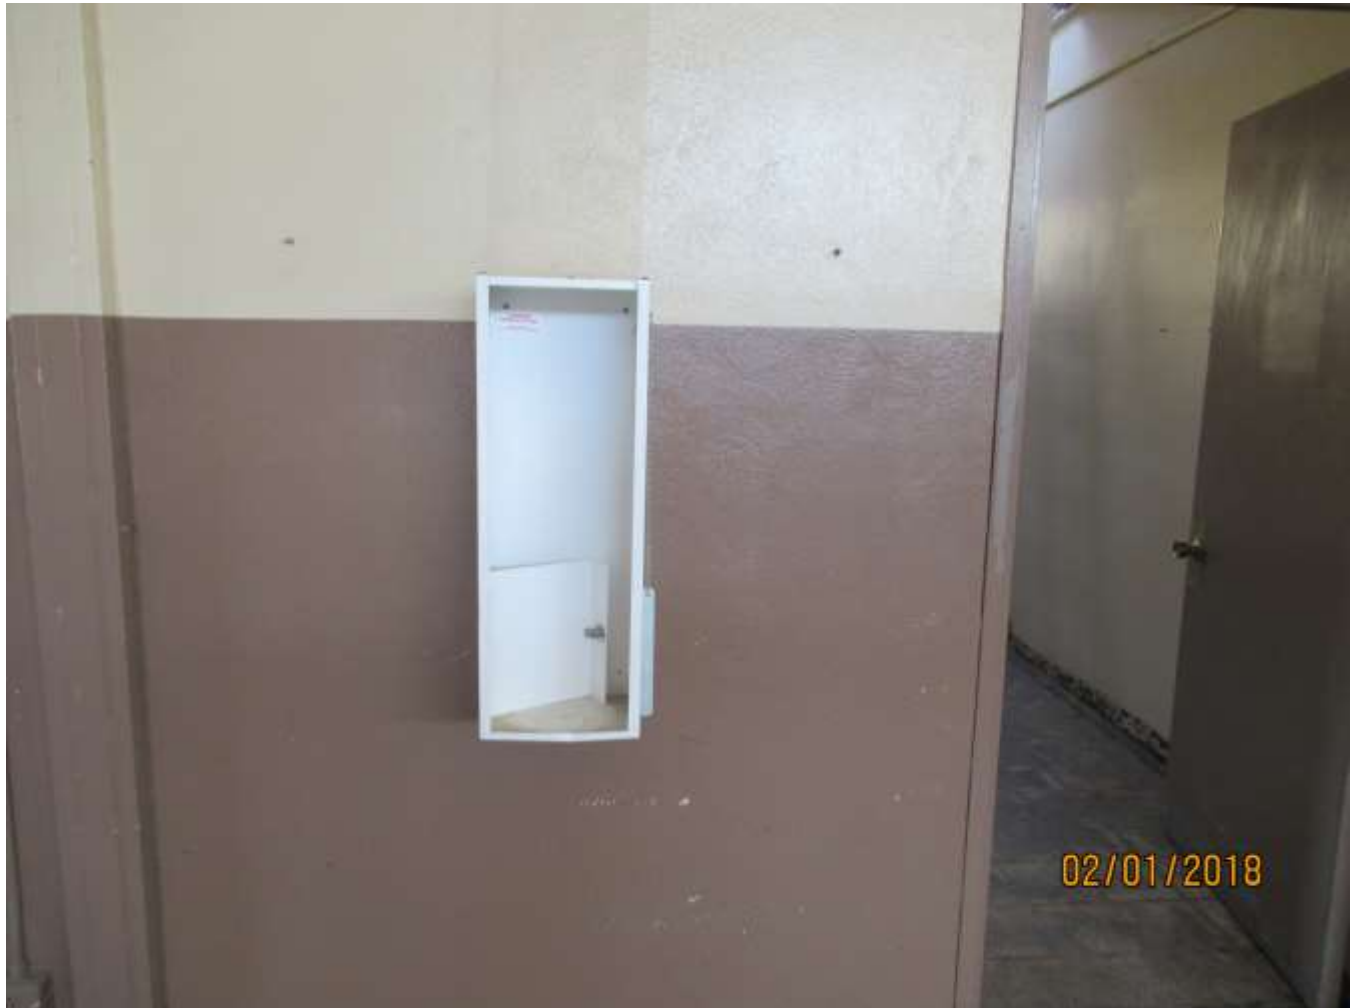
PHOTO 1

Example of typical missing fire extinguishers

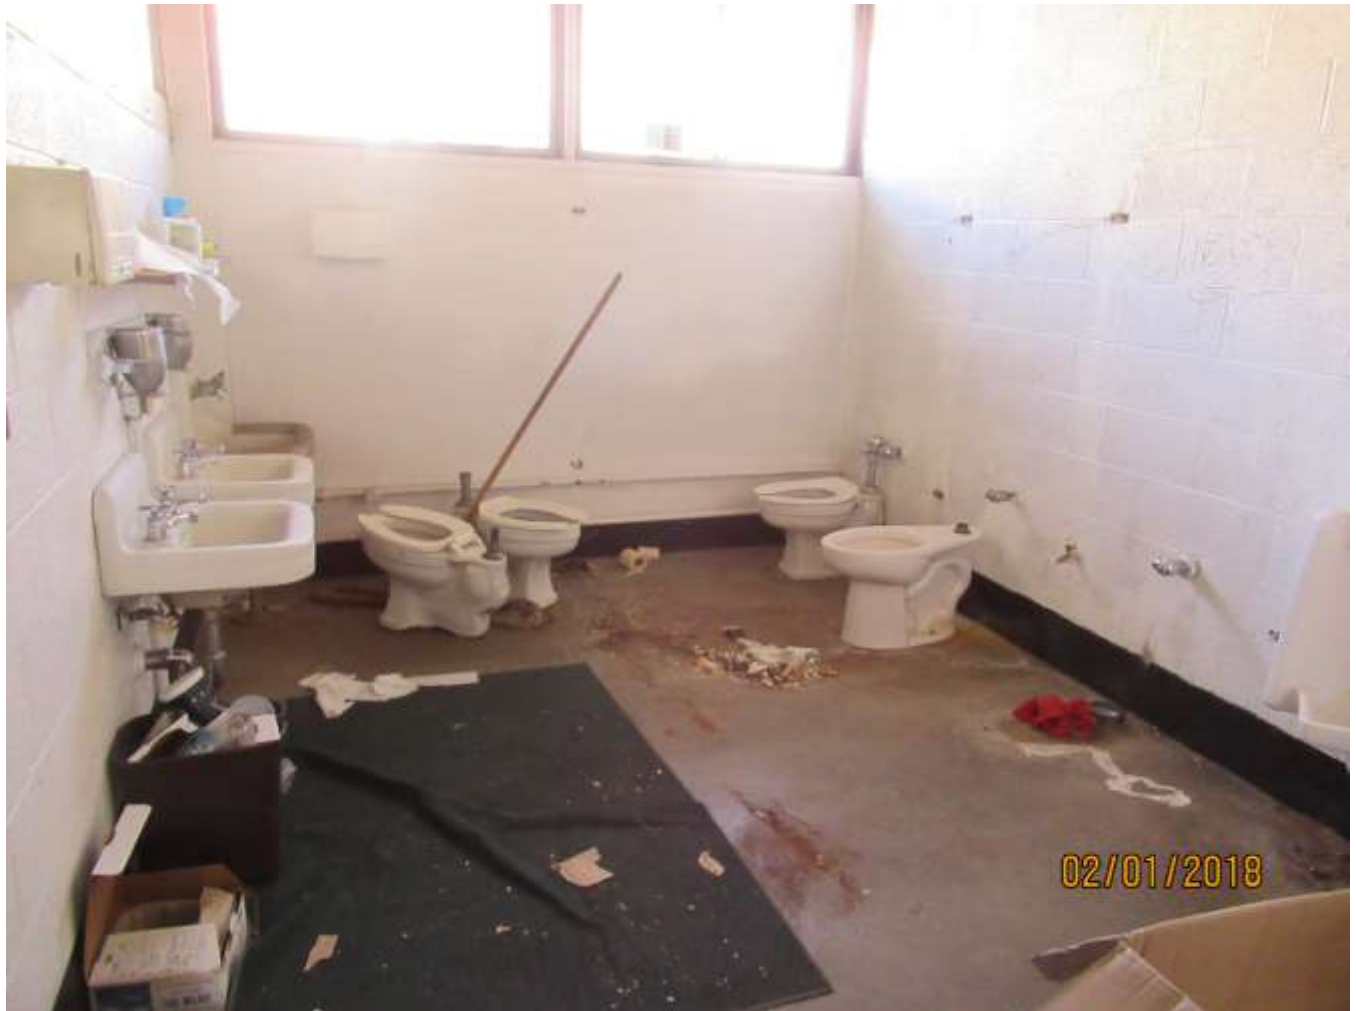
PHOTO 2

Example of typical poor condition of the restroom interiors

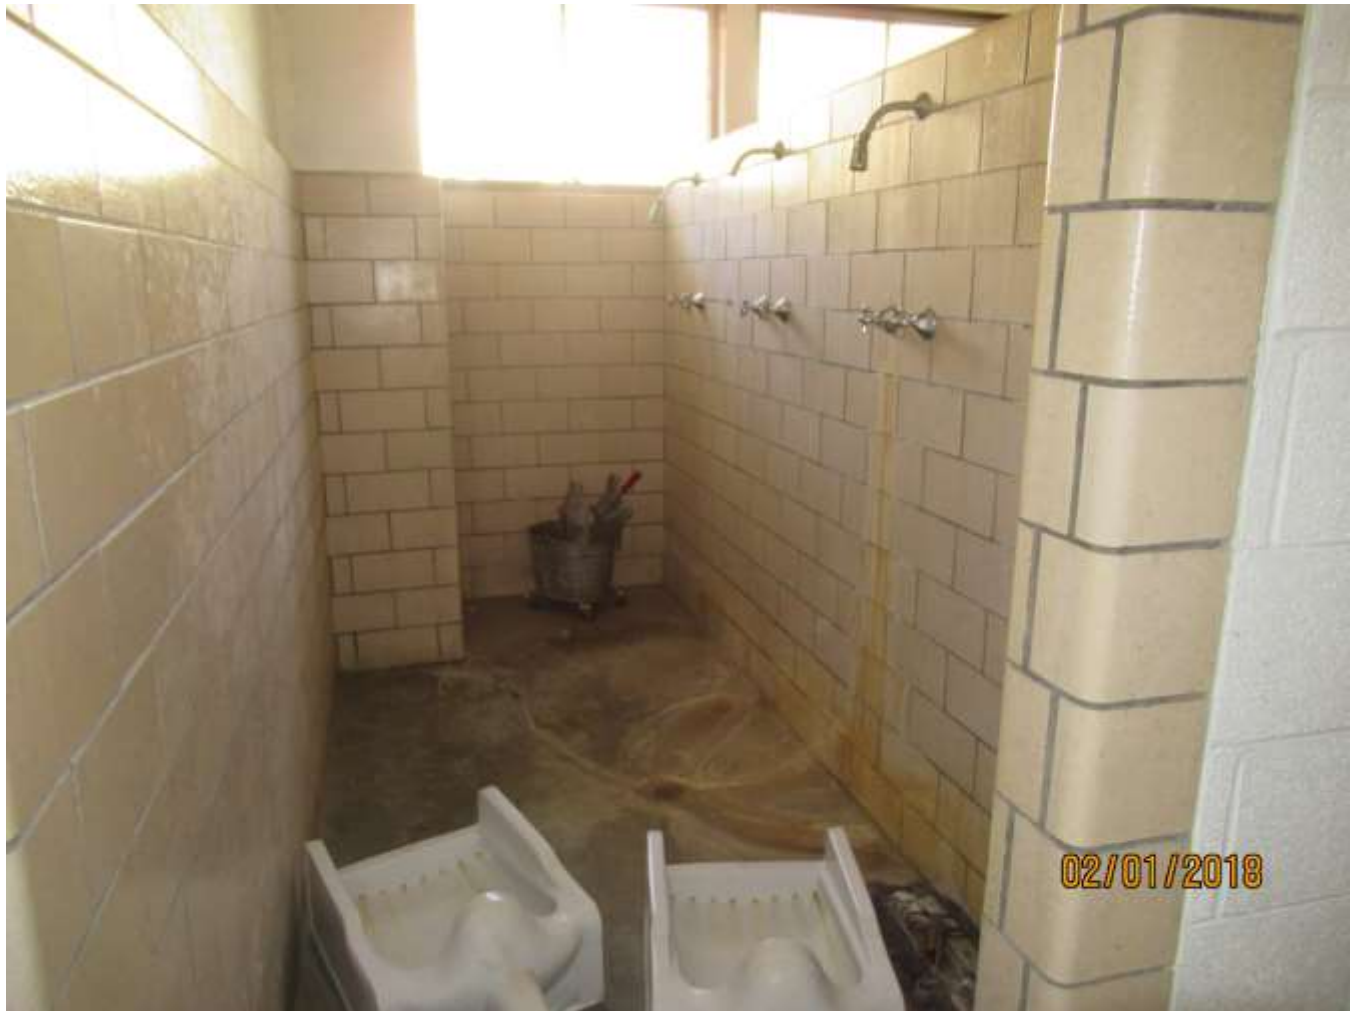
**PHOTO 3**

Example of typical poor condition of the shower room interiors
