# Building Assessment Report

Inspection Address: 617 Texas St.  
Redlands, CA 92374

Prepared For: City of Redlands

Report Number: BARIECR9

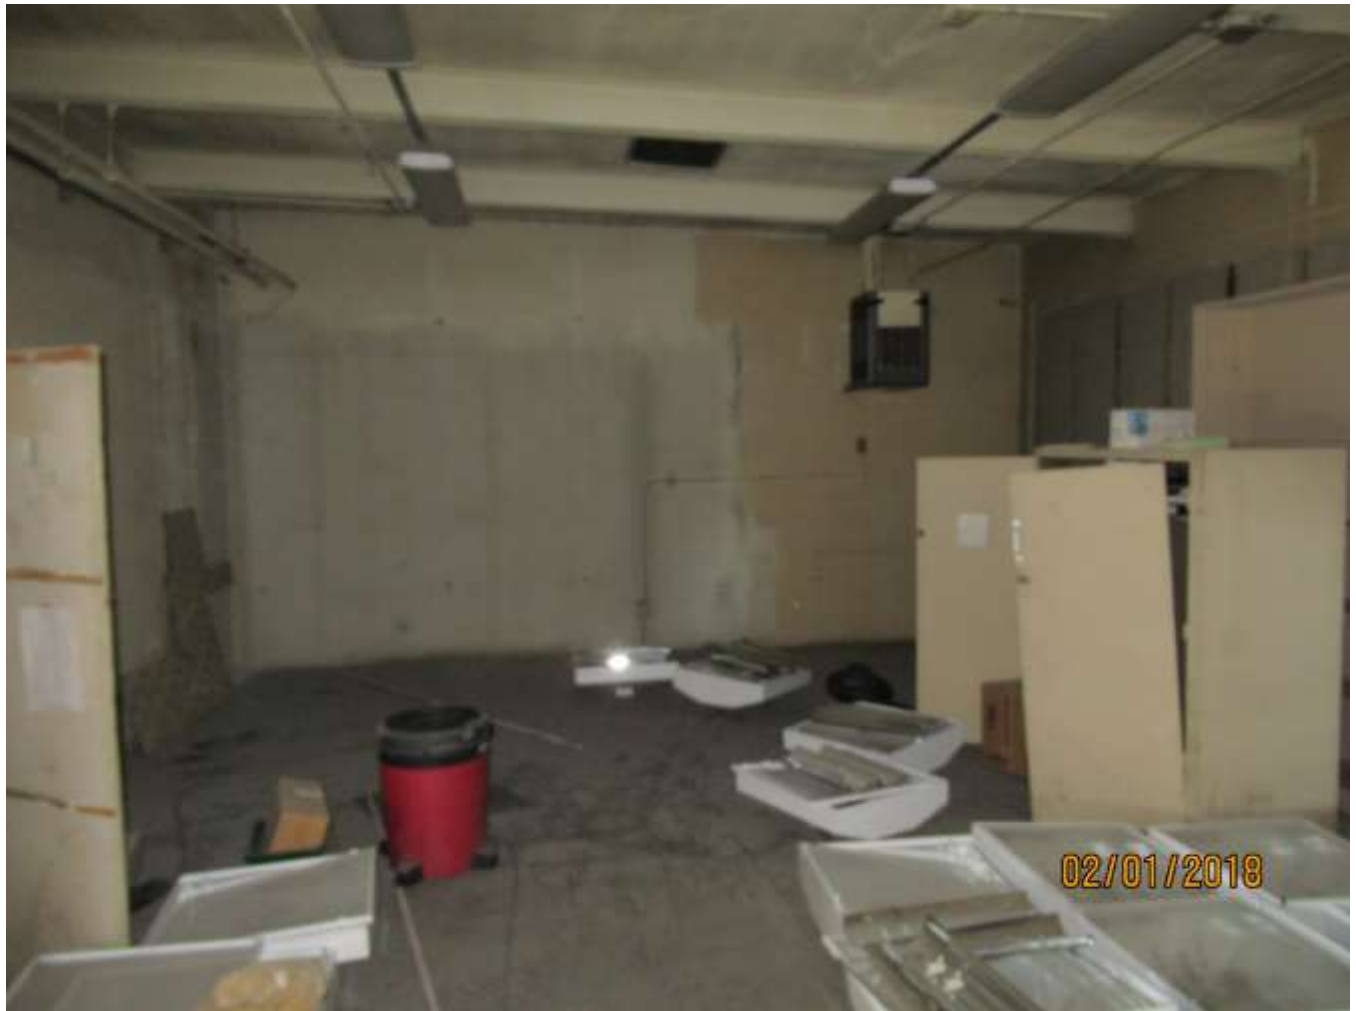
PHOTO 4

Example typical poor condition of the office section of the building

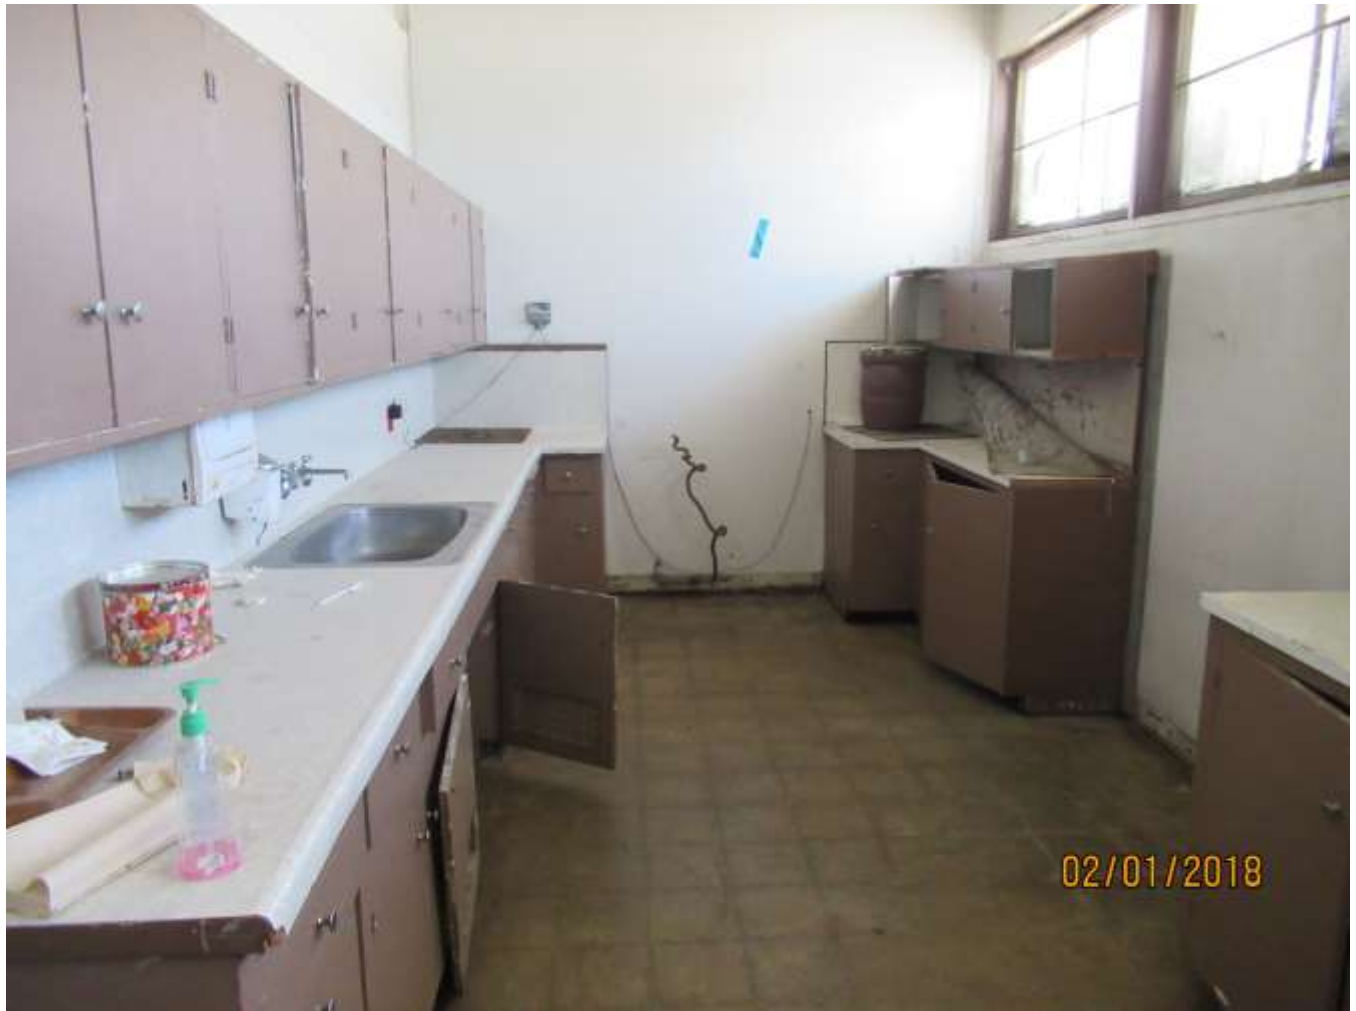
PHOTO 5

Example of typical poor condition of the kitchenette area of the building

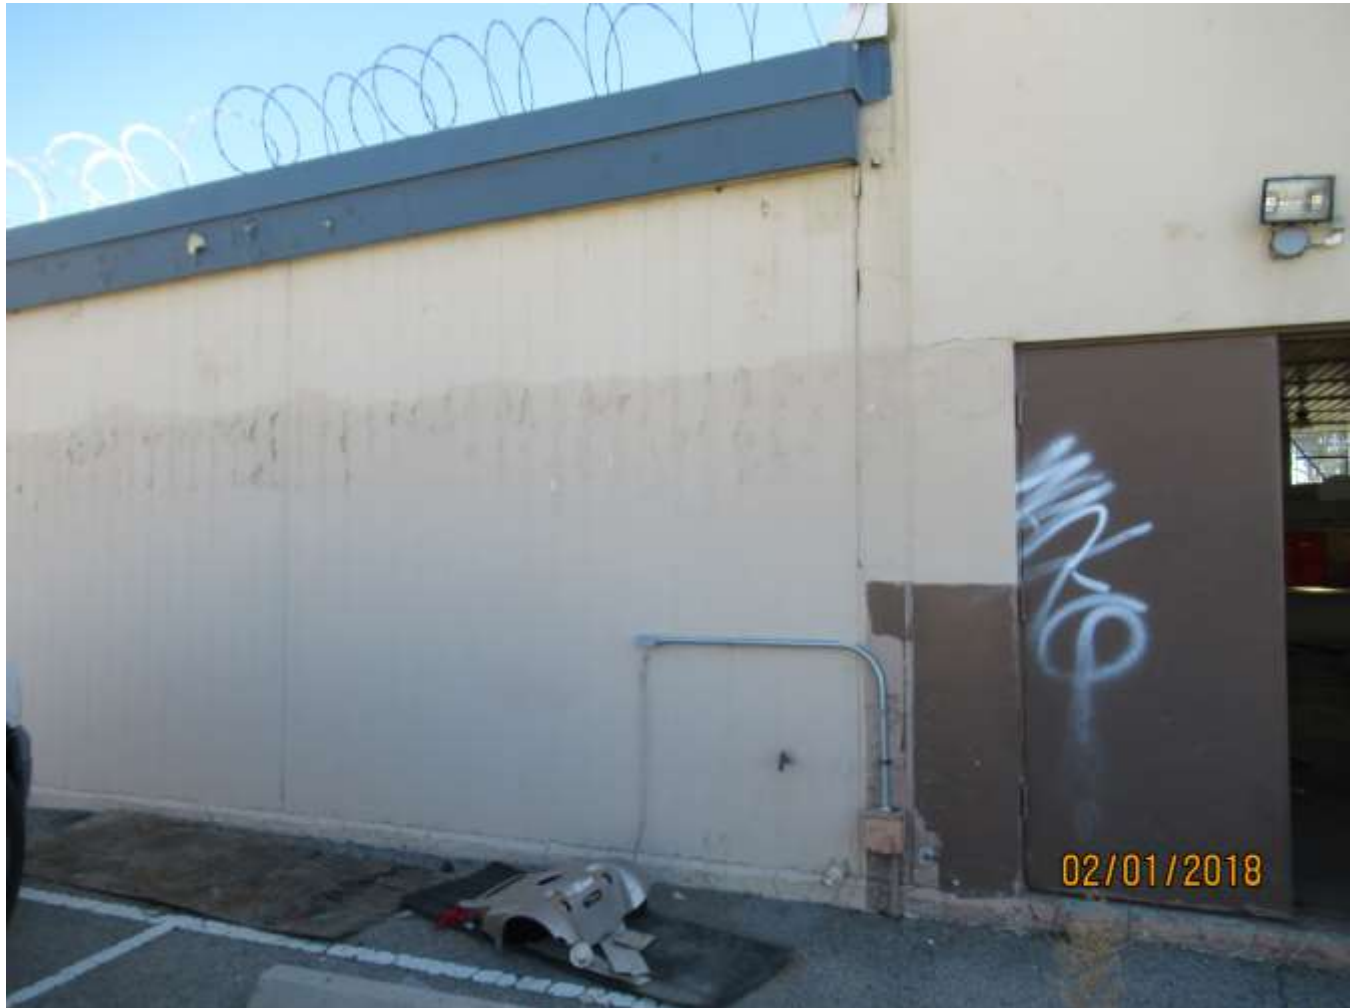
PHOTO 1

10.2.1 Building exterior paint was noted to be at the end of its useful life. Minor settlement cracking of the exterior concrete wall panels was noted. This may allow moisture intrusion into the interior of the building. It is recommended to repair all settlement cracking and repainting the building exterior. Periodic painting (every 7 years) of the building's exterior and remedial wet sealing of the window system seals will be required to maintain the good condition and attractive appearance.

Example of typical exterior paint at the end of its useful life

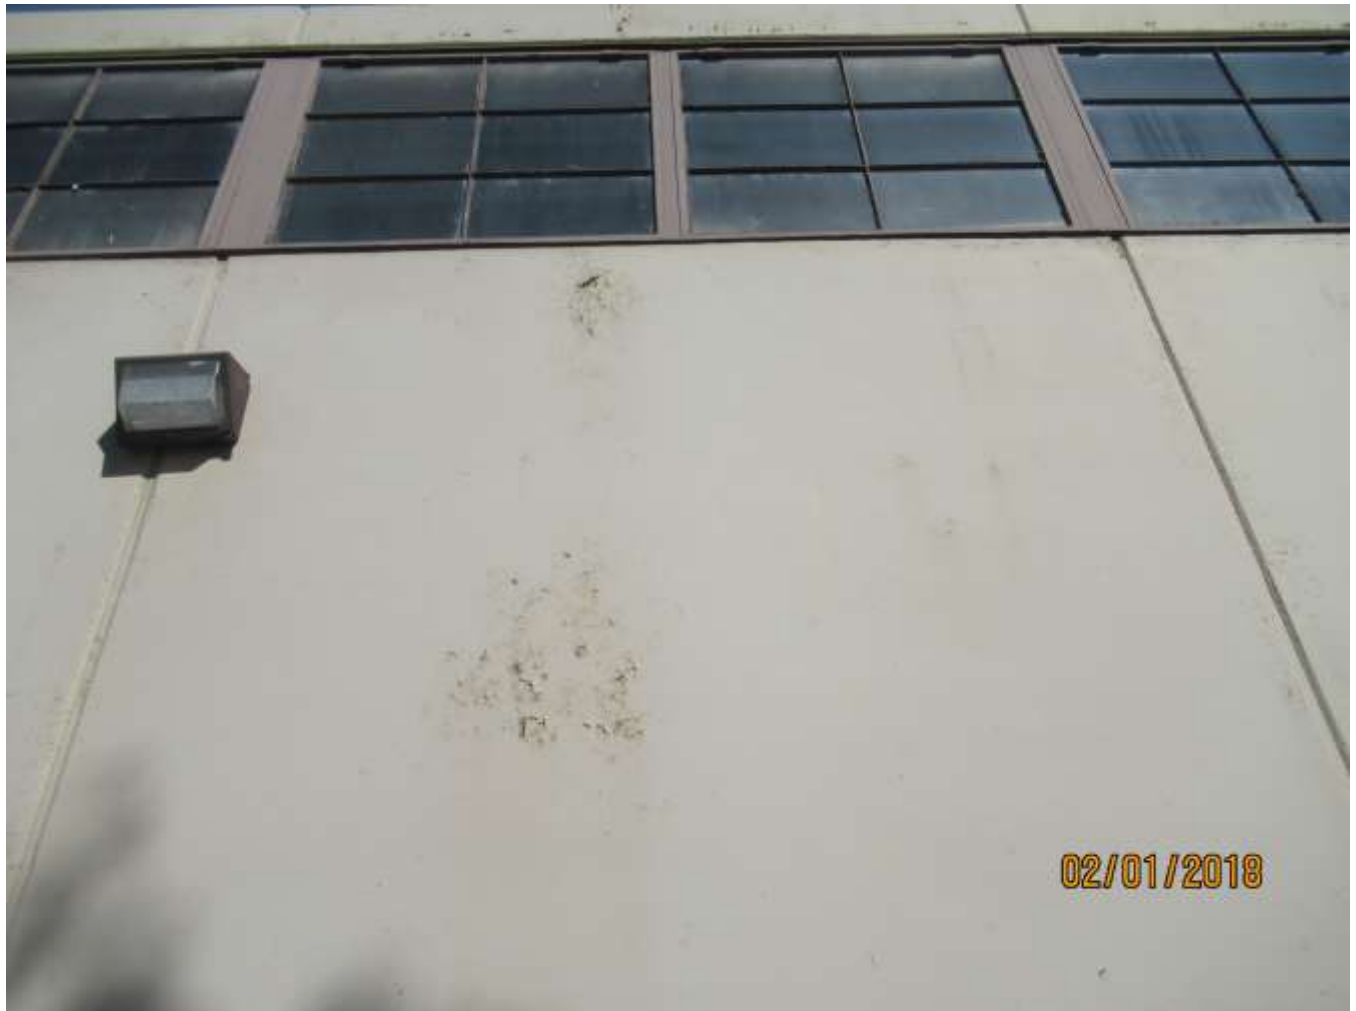
**PHOTO 2**

Example of close-up of typical peeling of the exterior paint

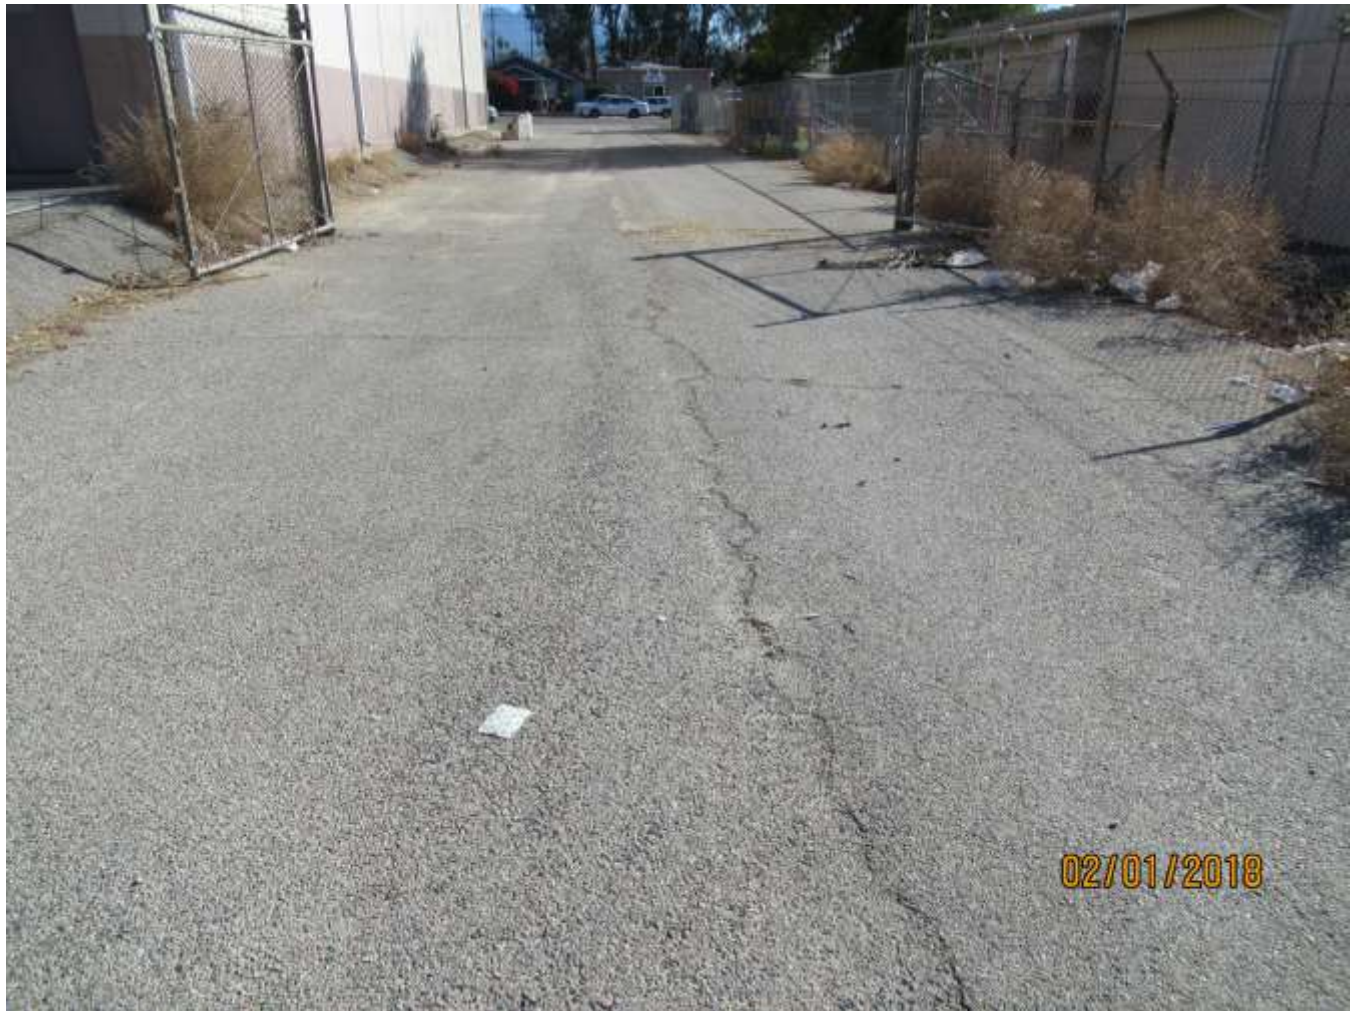
**PHOTO 3**

10.2.7 The asphalt paving was noted as having cracking and minor depressions. It is recommended to patch the depressions, install a 1" overlay of new asphalt and re-stripe the parking lot.

Example of typical cracking and worn slurry seal of the asphalt parking/drive surfaces

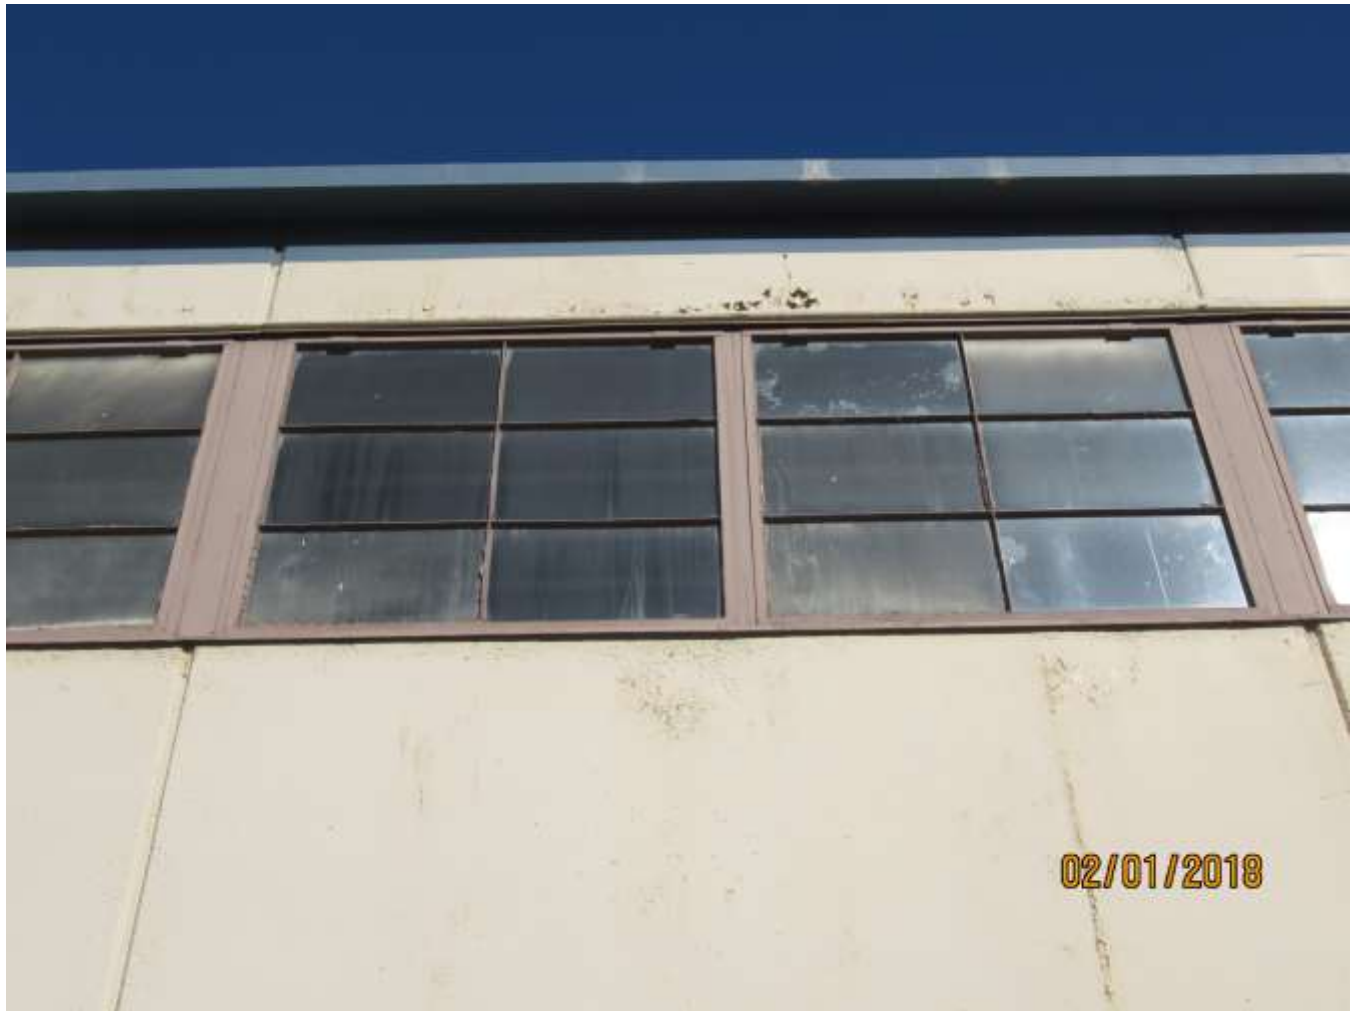
**PHOTO 4**

10.2.4 All of the window systems for the main building were noted to be passed their effective useful life and I required to be replaced.

Example of older warehouse window systems that require replacement

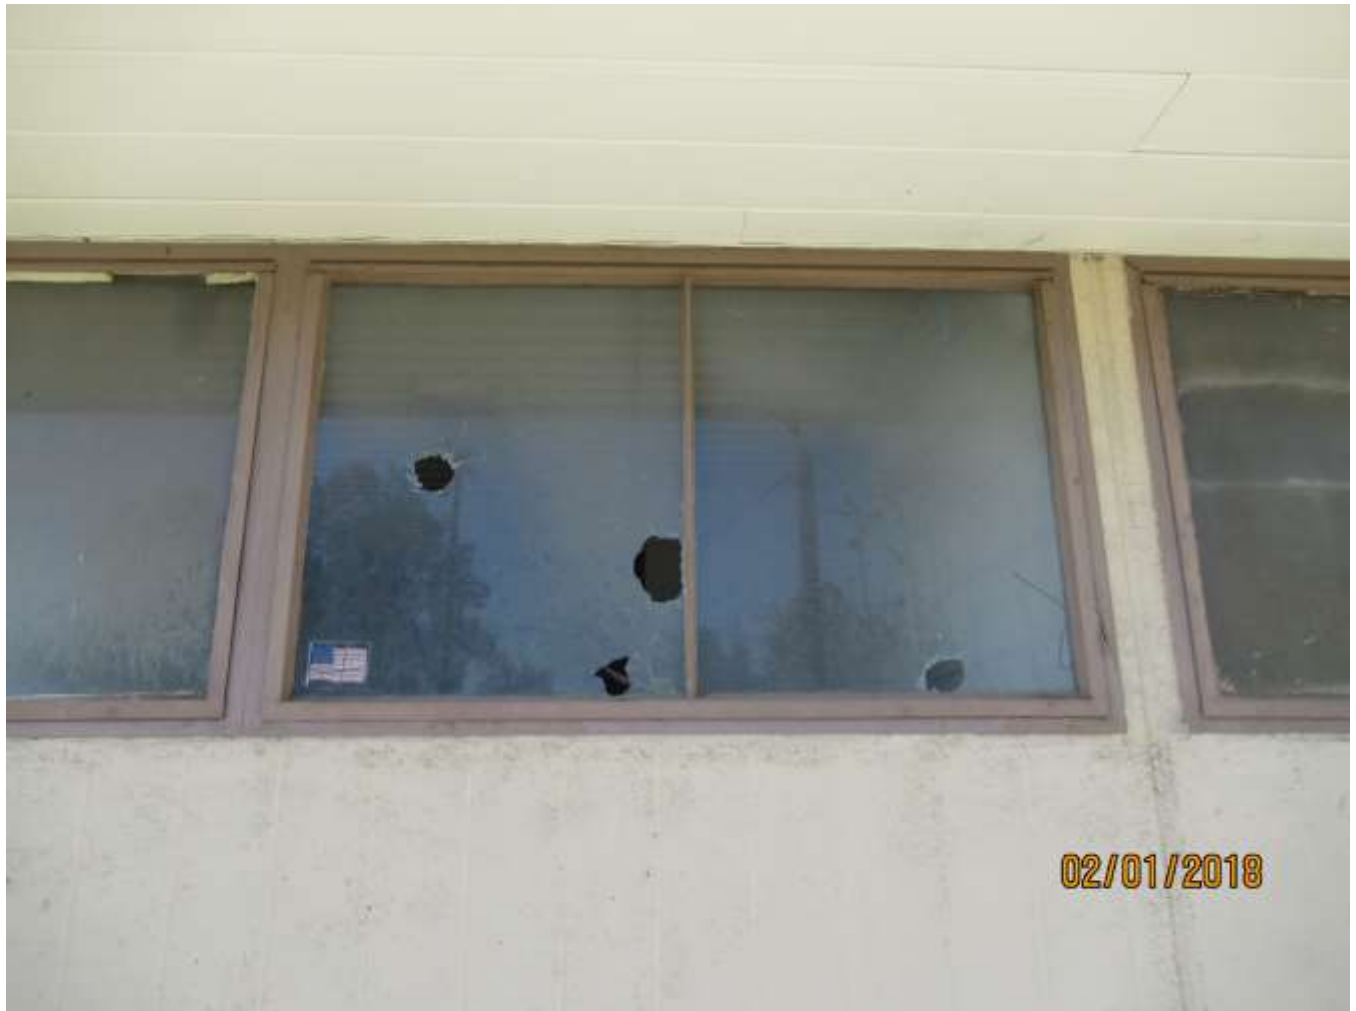
**PHOTO 5**

Example of typical front office windows with impact

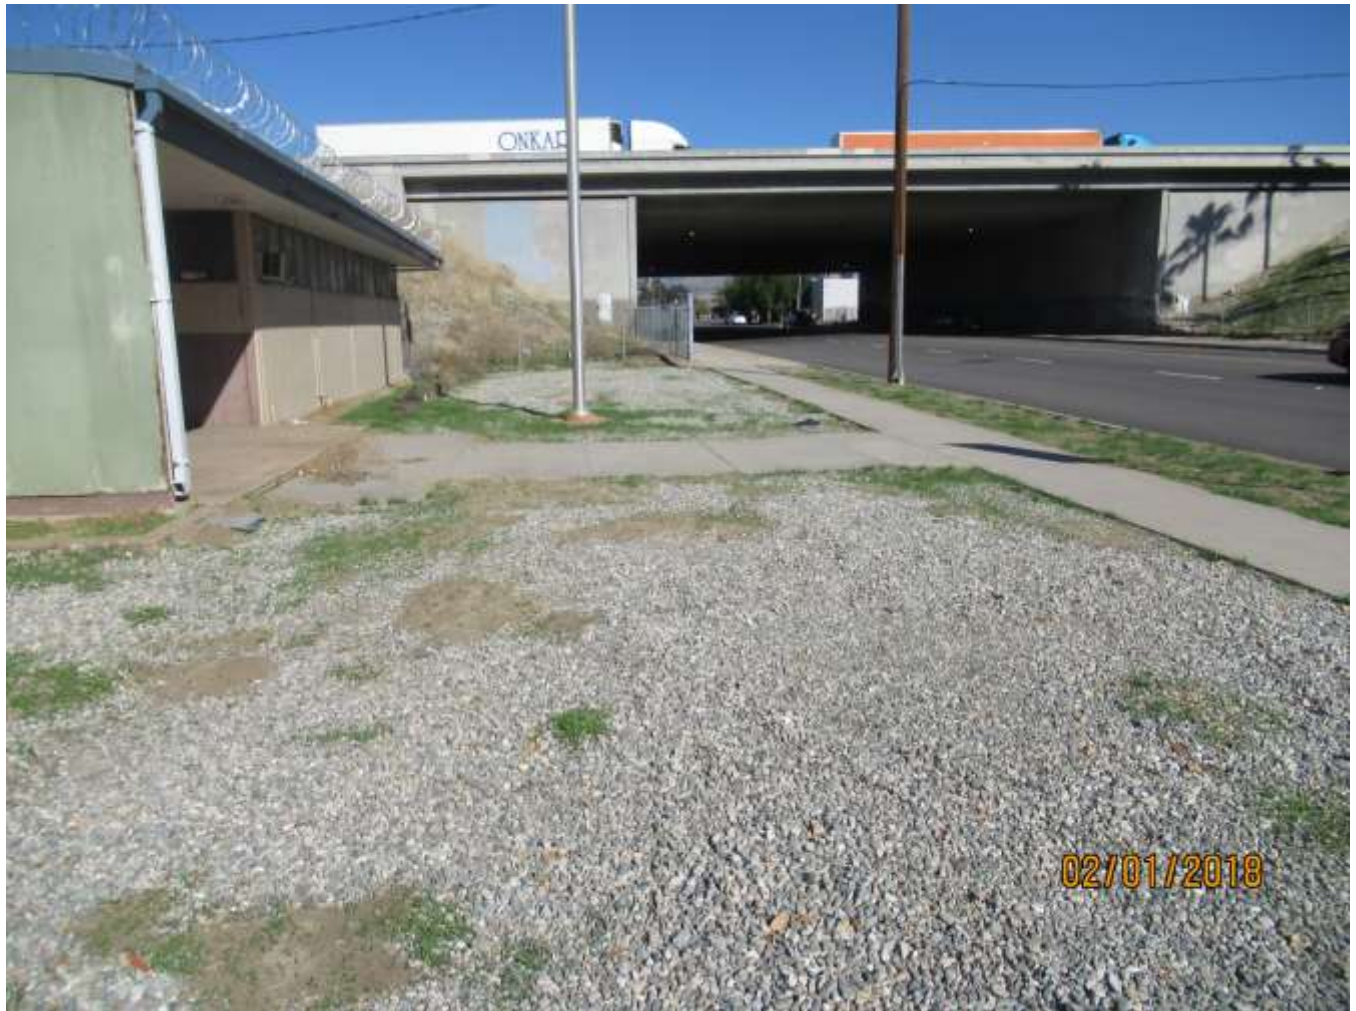
PHOTO 6

10.2.9 Barren sections of landscaping were noted throughout the site that are required to be improved. It is also recommended to have the entire irrigation system tested and repaired as needed and improve barren sections of landscaping

Example of the front of the site that requires landscaping improvements

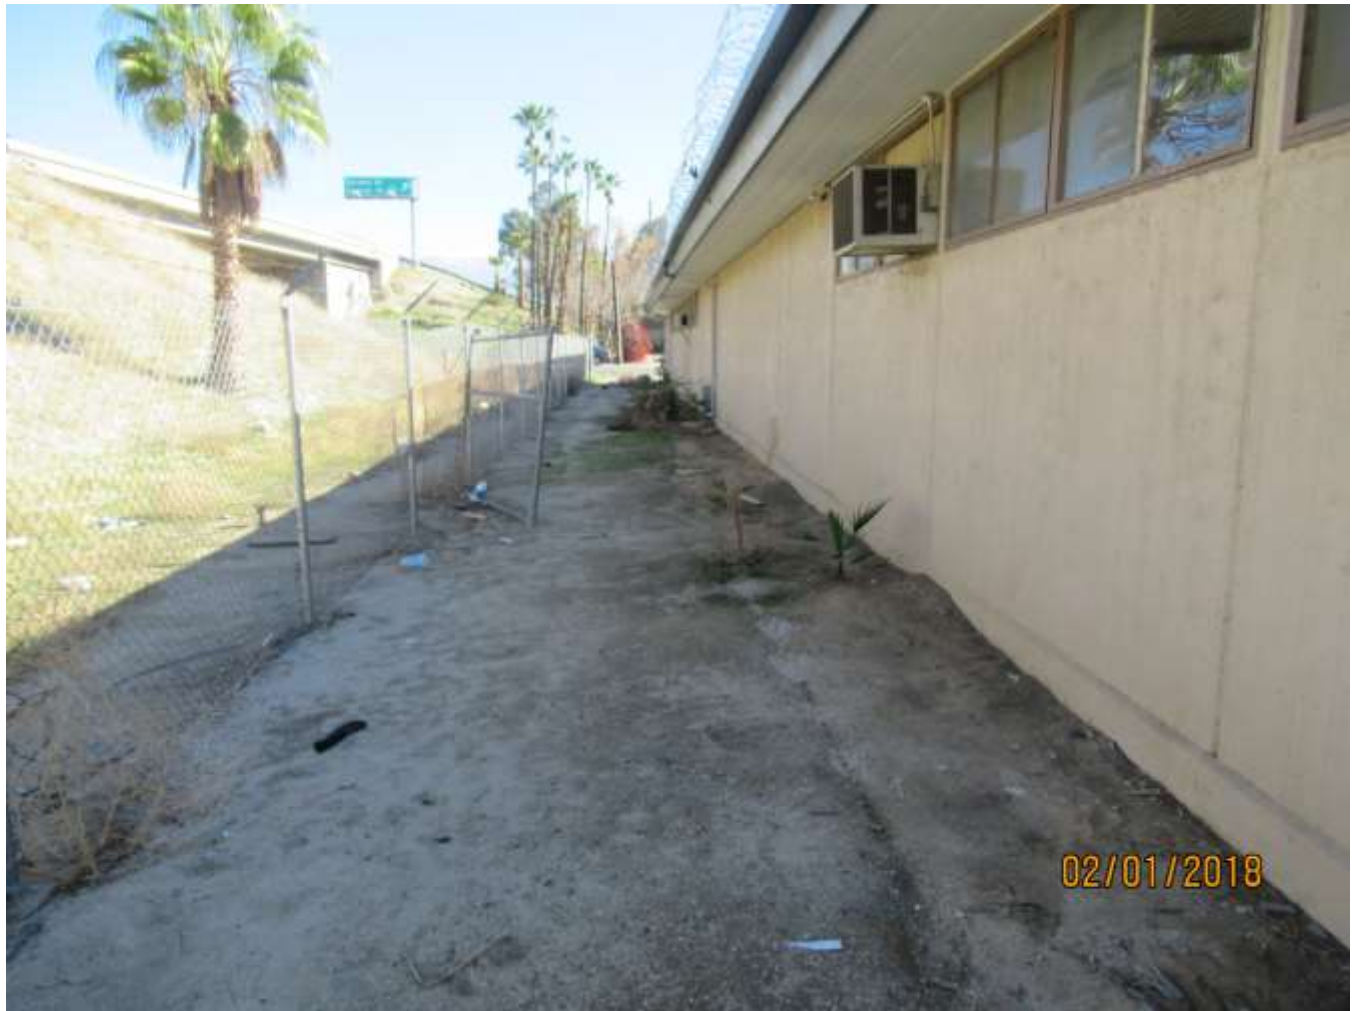
**PHOTO 7**

Example of the north side of the building that requires landscaping improvements

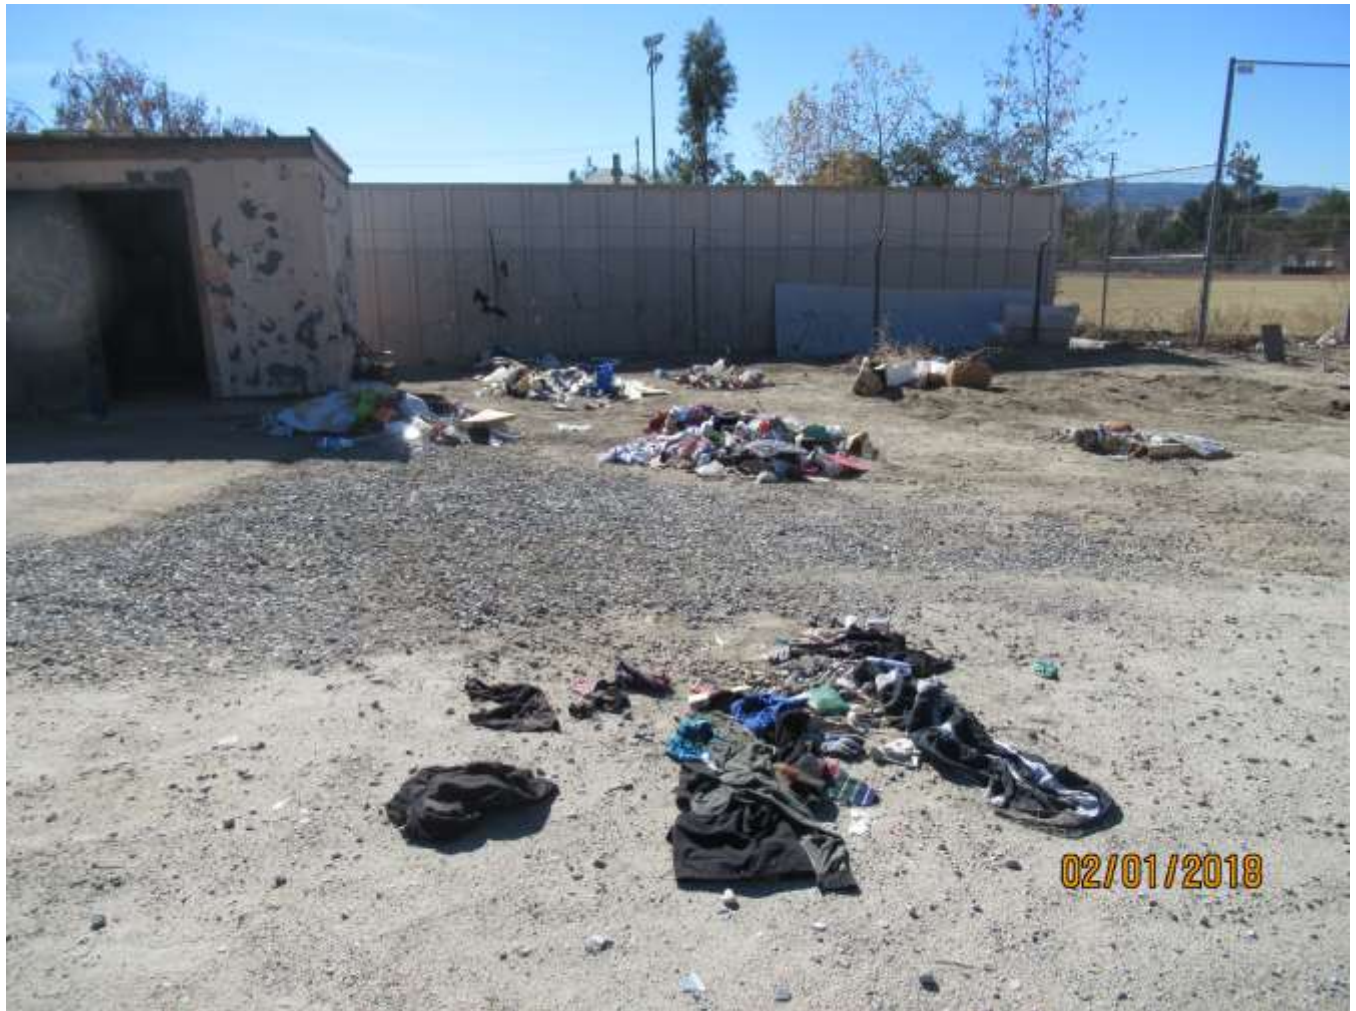
**PHOTO 8**

10.2.11 Debris was noted throughout the exterior of the side that's required to be cleaned up and properly disposed.

Example of typical debris on the site

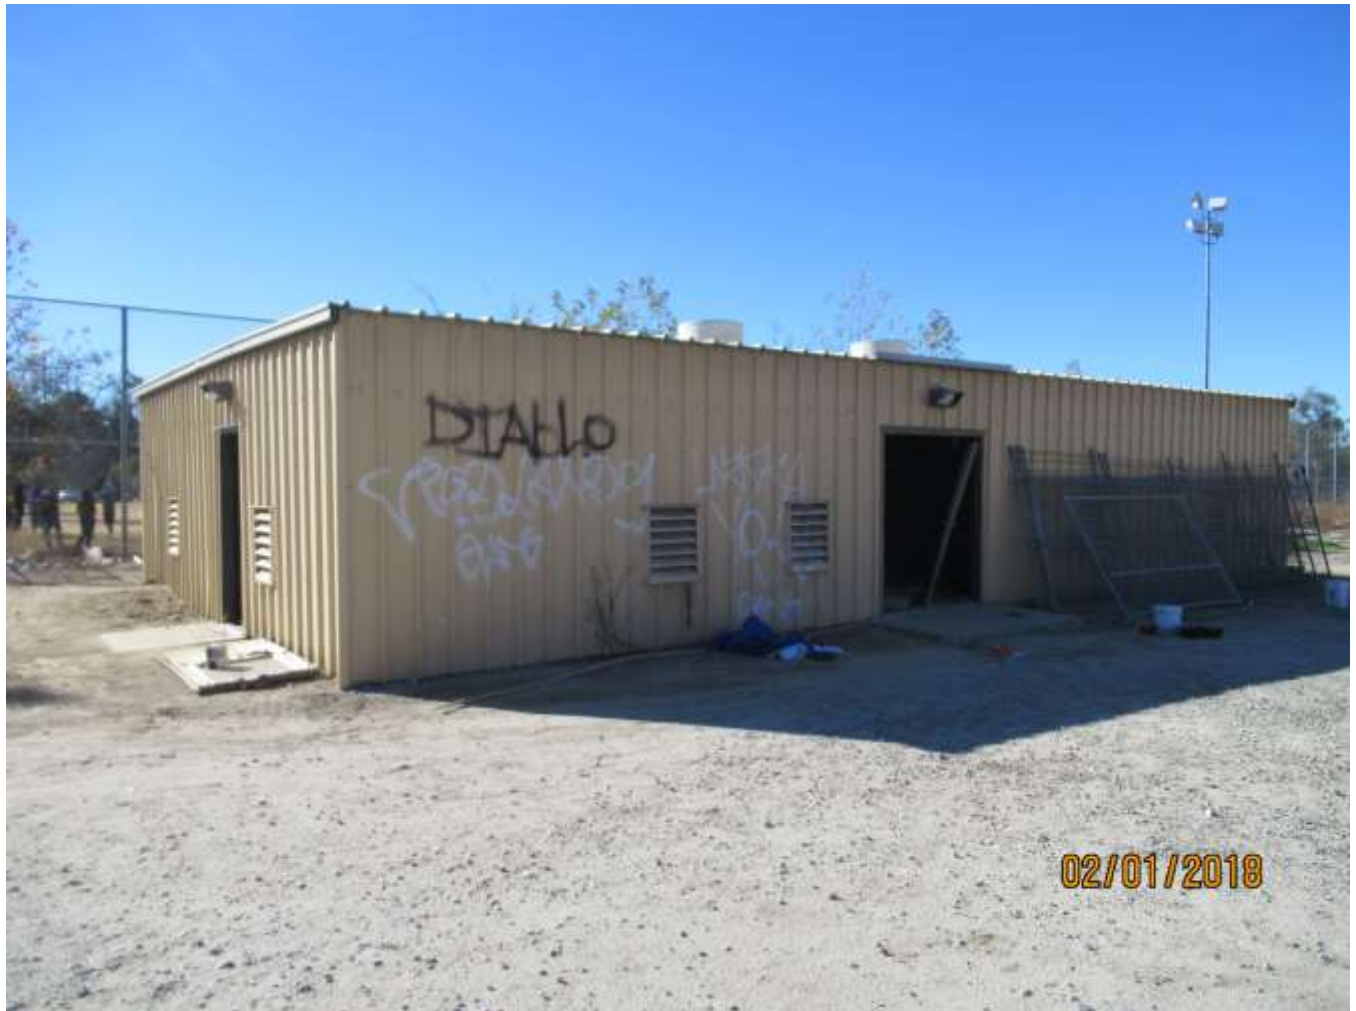
PHOTO 9

10.2.10 The two storage sheds at the west side of the main building were noted to be full of debris that is required to be removed and require general repairs to include painting the exterior of the buildings, installing an elastomeric coating to the roofing systems, replacing all doors, replacing the electrical systems and lighting and a general power washing and decontamination of the concrete floors.

Example of typical storage shed exterior

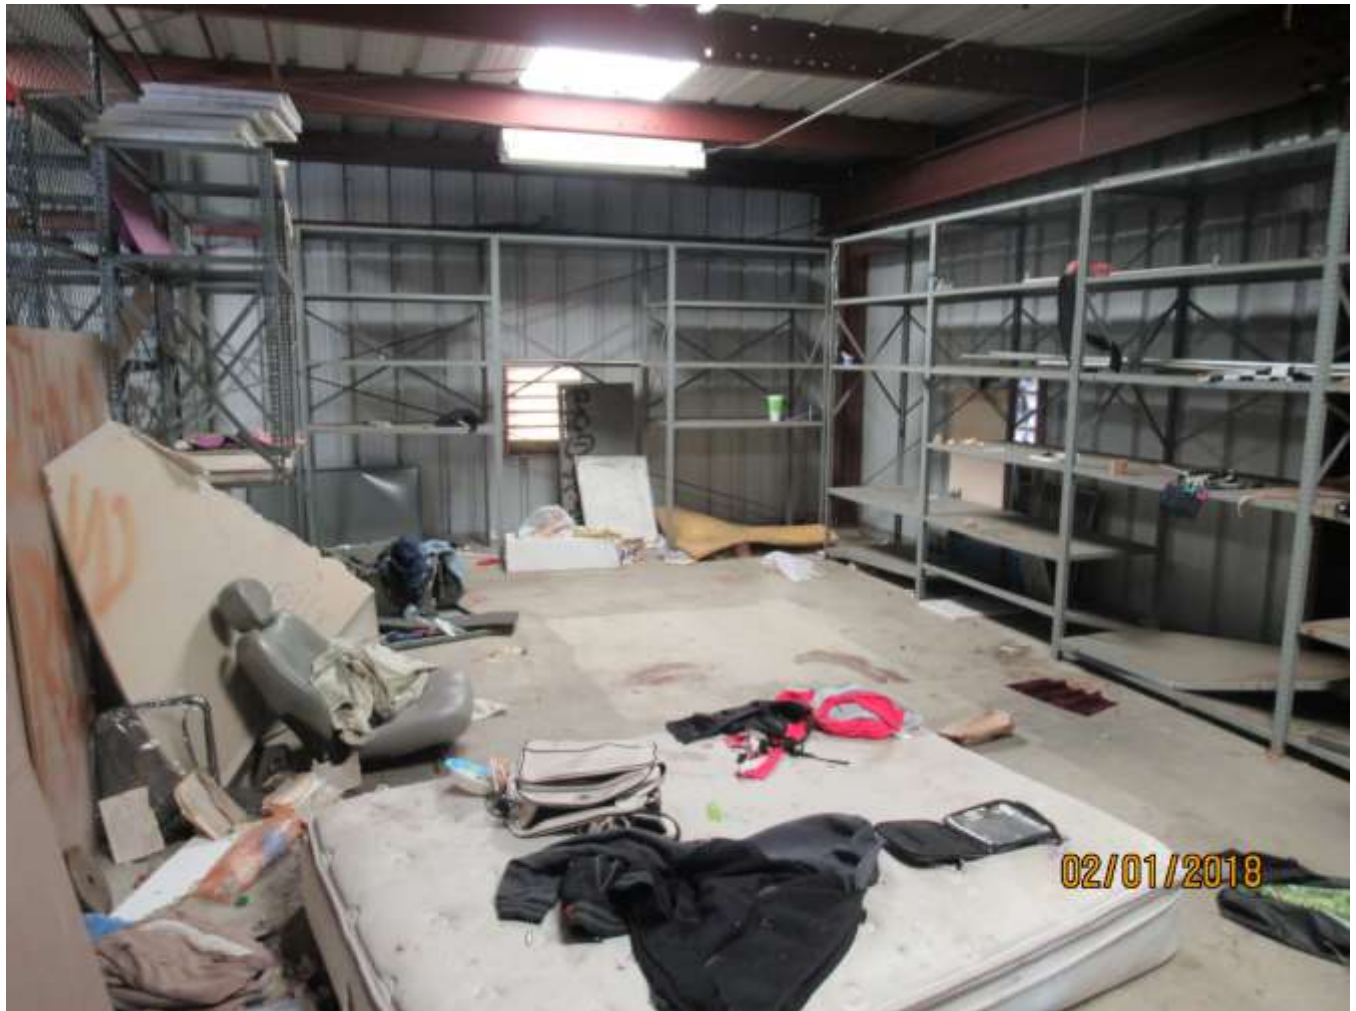
PHOTO 10

Example of typical storage shed interior
